10.1002/2015JB012174

Insights from heterogeneous structures of the 1999 M_w 7.6 Chi-Chi earthquake thrust termination in and near Chushan excavation site, Central Taiwan

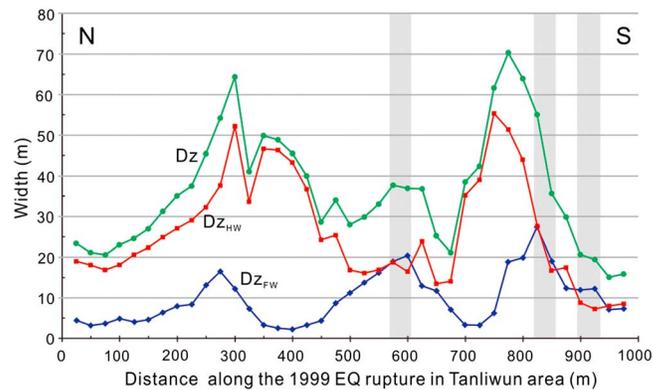
Figure 3. Width variation of deformation zone (Dz) in the Tanliwun area. Dz boundary in the hanging wall at the shaded parts was poorly constrained because of steep slope and dense vegetation right next to the 1999 earthquake rupture. The subscripts HW and FW mean hanging wall and footwall, respectively. The two Dz peaks occur near location B and G in Figure 2.

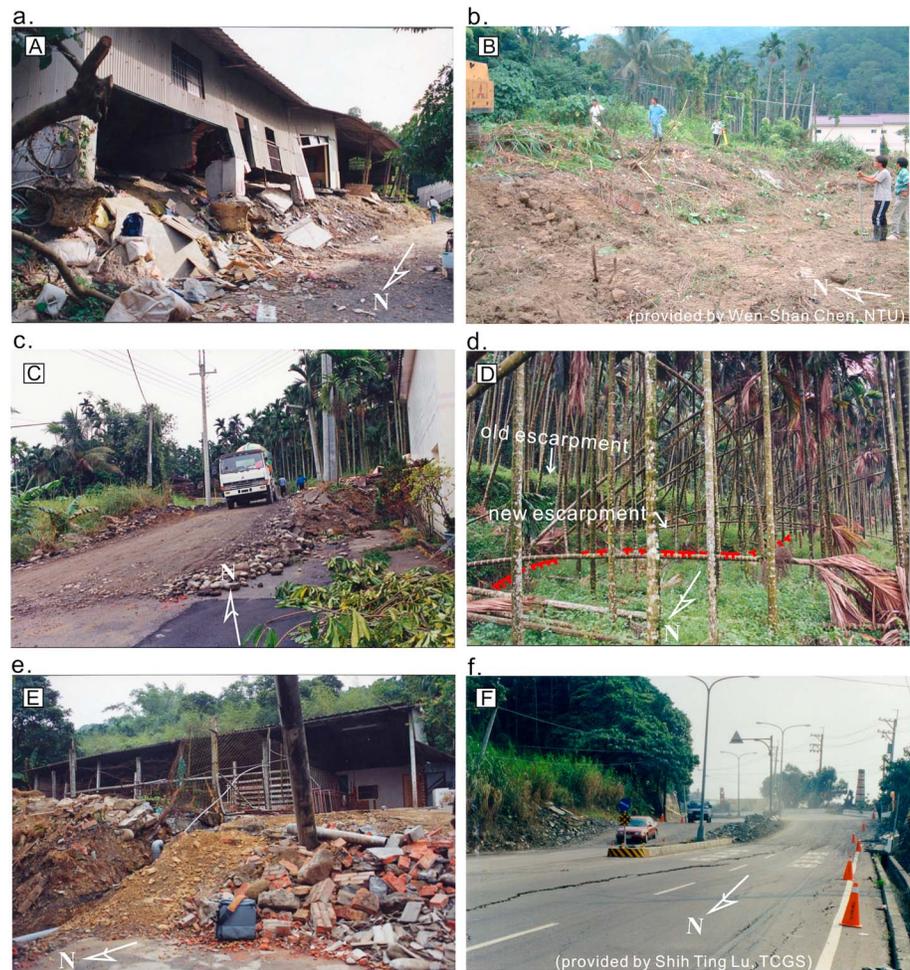
In the upper right of Figure 2, at location A, the escarpment of the deformation zone trends NNE to SSW (Figure 4a). Before the Chi-Chi earthquake, the ground surface in this neighborhood was flat. After the earthquake, the floor of the storage shed was uplifted on a 2 m high monoclinical escarpment. The shed was distorted, and some of the foundation piers supporting the columns of the building were exposed. The escarpment extended southward tens of meters from location A. We could not trace the escarpment all the way to location B (Figure 2) because of dense vegetation and a steep slope associated with the riser between the lower terrace and the Coastal Plain.

South of the creek near location D (Figure 2), the trend of the escarpment changes from NW to NE. The foundation of a concrete bridge across the creek was damaged and displaced about 1.0 m on either side of the creek. Figure 4d is a southeast view of the escarpments. The upper escarpment in the background is the riser of the upper terrace. The lower escarpment, approximately 1.0 m high, was formed during the Chi-Chi earthquake. Its trend can be recognized by the lineament of tilted betel-nut trees.

Farther south, the escarpment trends roughly ENE in the southernmost one-third (Figure 2). At location E, the floor of the barn used to be at the same level as the cement slab in the foreground before the earthquake (Figure 4e). After the earthquake, the ground had been uplifted about 1.0 m. A pipeline was broken, and an electric pole was tilted by the deformation. Figure 4f shows the earthquake damage on Province Road 3 at location F (Figure 2). The road surface was flat prior to the earthquake. During the earthquake, the southern side was uplifted 1.3 m and displaced 1.4 m in the right-lateral sense, as shown on right edge of photo.

Figure 4. Chi-Chi earthquake-induced escarpments in the Taniwun area (locations shown in Figure 2). Detailed description of each escarpment refers to the text.

During the earthquake, the trace of an escarpment passed through the site of the house and the formation of the escarpment destroyed the house. The ground surface at the escarpment appeared as a low warp (Figures 4b and 8b).

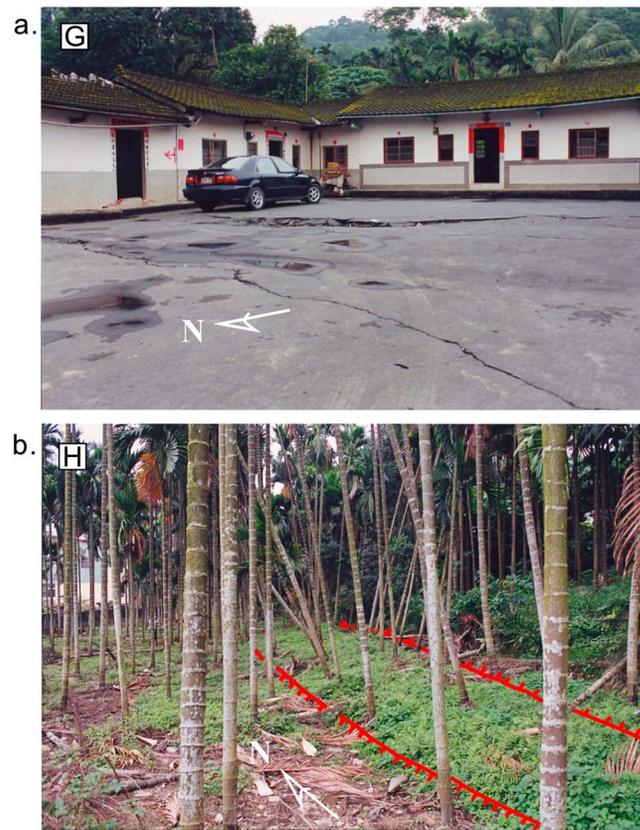
Ground deformation in the footwall was observed at only two locations G and H (Figure 2). At location G, two fractures appeared in the courtyard of a U-shaped house (Figure 5a) 20 m NW of the escarpment, which was 1.0 m high. The fractures and flexures in the asphalt pavement indicate thrusting, with the ground in the hanging wall moving relatively toward the NW, similar to the main escarpment itself. Thrusting extended laterally and damaged the house. The amount of uplift by thrusting in the pavement, though, was on the order of 20 to 40 cm. There was no damage or visible deformation in the asphalt pavement to the north of the two fractures, neither in between the south fracture and the main escarpment.

The other location is 50 m northwest of the trench site (location H in Figure 2). The ground surface was deformed as an elongated dome with a hinge line parallel to the escarpment at the western edge of the lower terrace. Figure 5b is a northeast view of the dome, which could be recognized thanks to a lineament of tilted betel-nut trees. Note that the betel-nut trees were inclined in an opposite direction on the opposite limbs of the anticlinal dome.

Figure 5. Geological features in the footwall induced by Chi-Chi earthquake faulting. (a) Two fractures and flexures appeared in the courtyard of a house (location G, Figure 2). The amount of uplift by thrusting in the pavement was on the order of 20 to 40 cm. (b) Northeast view of an anticlinal dome (location H, Figure 2). The betel-nut trees were inclined in an opposite direction on the either limb of the dome. The toes of the anticlinal dome are highlighted in red with tip marks, which indicate the down-thrown side.

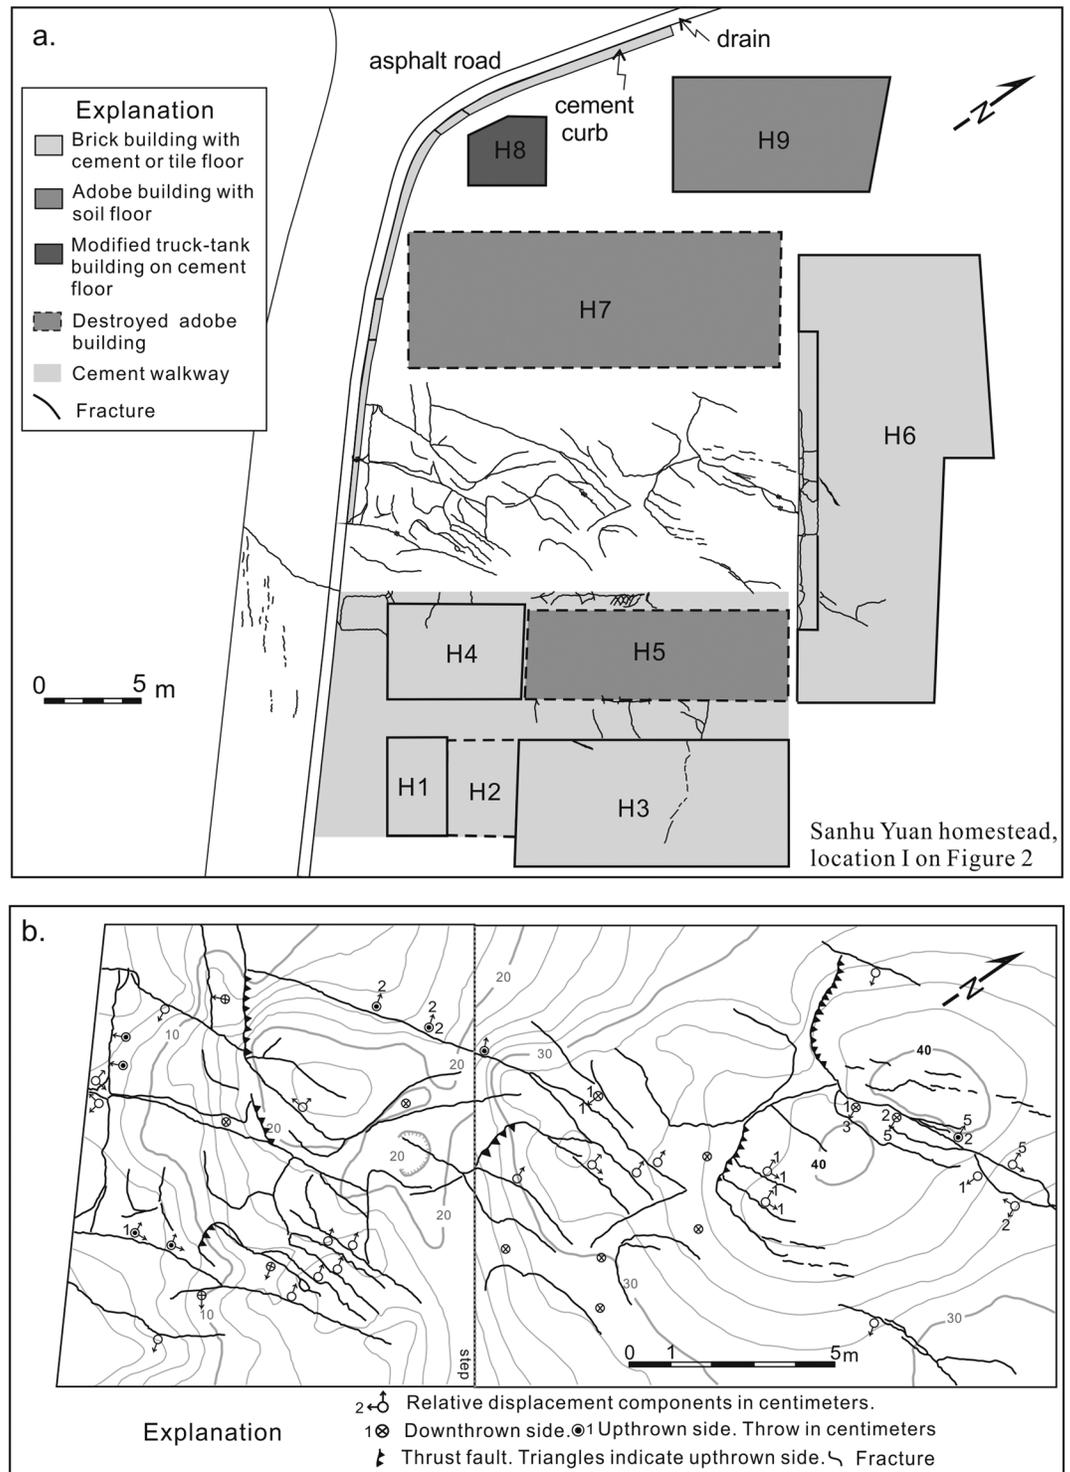
The courtyard of the Sanhu Yuan was a flat surface of asphalt prior to the earthquake, used for drying harvested rice. The earthquake caused the asphalt to become bumpy and fractured. The diameters of the bumps are on the order of 5 to 15 m. The maximum relief of the bumps reaches 40 cm (Figure 6b). Most of the fractures are open (Mode I) cracks and are oriented roughly NE-SW. Crack openings are 0.5 to 1 cm on average. The openings narrow toward to the ends. The maximum opening within the fractures is 5 cm. Some fractures extend several decimeters into the ground. The typical shapes of the crack walls are zig-zag. The traces of the cracks are preferentially oriented about NE-SW, indicating

Figure 6. Deformation of a Sanhu Yuan, traditional Taiwanese homestead, in the hanging wall. (location I, Figure 2) (a) Building setting and traces of fractures in the homestead. (b) Topography (contour interval 2 cm) and traces of fractures in the courtyard (contour interval 2 cm). The courtyard was paved with asphalt.

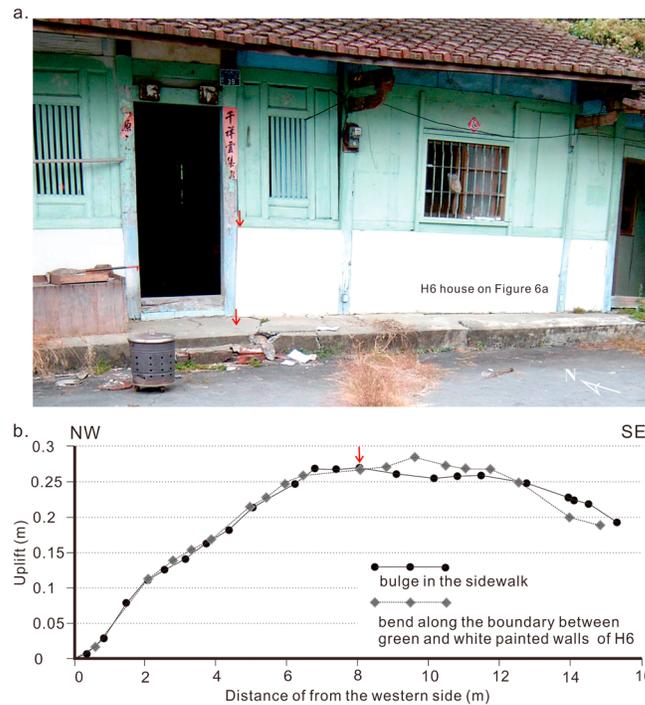
Brick house H6 was bent, distorted, and cracked (Figure 7a). We used an electronic theodolite (Wild T1000) to measure the bending along the floor of the porch and the line between the green and white painted walls (Figure 7a). The survey (Figure 7b) shows that the middle of the house was relatively elevated about 28 cm, while the eastern end of the house was relatively elevated about 18 cm in reference to the western end. The uplift of the house H6 along an axis oriented NW-SE may well be a result of a thrust fault that accommodated small thrust offset. Perhaps the small thrust fault or other thrust faults were beneath the broad domes in the courtyard. In any case, the structures in the asphalt in the courtyard and the deformation within house H6 clearly reflect thrusting resulting from NE-SW compression in the Sanhu Yuan, which is consistent with thrusting in the Chushan trench during the 1999 earthquake.

Figure 7. Example of a damaged building in the Sanhu Yuan. Red arrows indicate measurement locations. (a) Northeast view of the building (house H6 in Figure 6). (b) Survey of the deformation along markers that were horizontal prior to the earthquake.

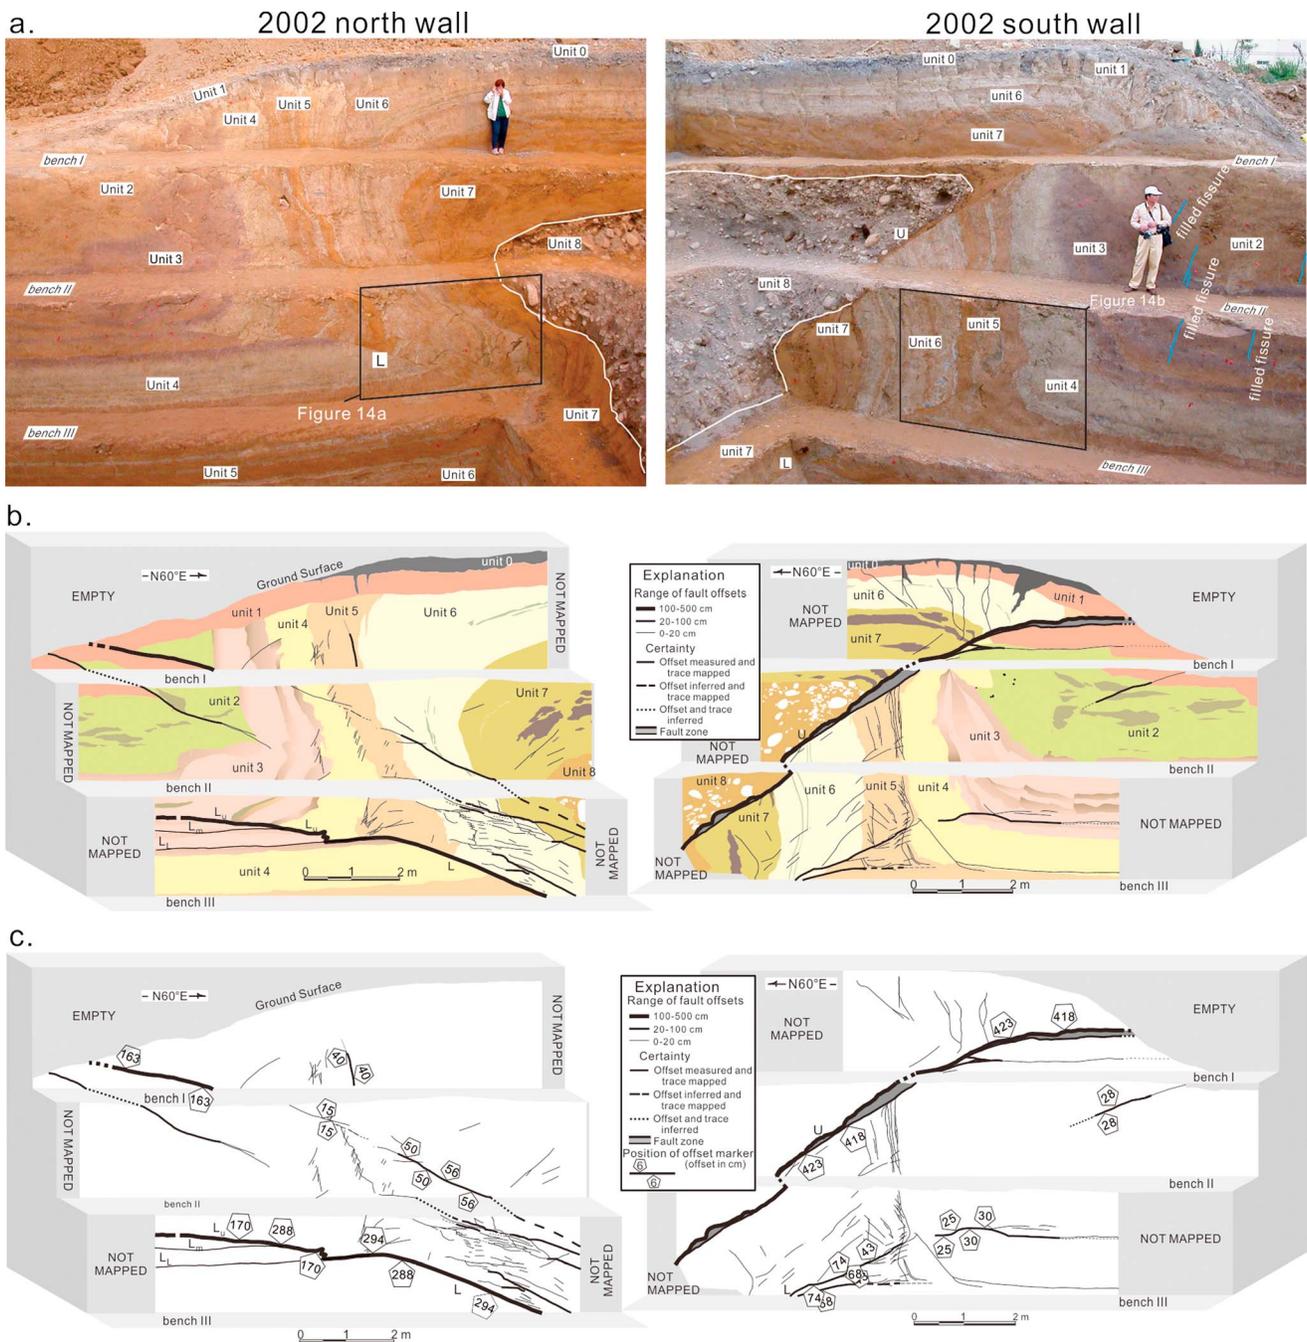
The trace of the upper main fault (labeled U in Figure 10, right) in the south wall ranges from a very thin line to a 15 cm wide zone; it separates distinctly different sedimentary layers. The fault dips at a shallow angle near the ground surface, but the dip increases to about 35° at a depth of 2 to 3 m and is constant at greater depths. The upper main fault was obviously active in 1999 because it cut through the topsoil to the ground surface.

The total offset on this fault is consistently about 4.2 m for Units 6, 7, and 8 (Figures 10b and 10c, right). The upper main fault is not observed in the north wall. It is visible in the lower left in Figure 10a (right) but terminates laterally toward the north face within the gravel (Unit 8) exposed in the NE wall of the trench. Along its trend, within the NE end of the trench, is a flexure defined by reoriented pebbles and a bend in the contact between the gravel and the overlying silt, Unit 7 (Figure 10a, left). The contact appears to be conformable in the flexure. Thus, the upper main fault definitely did not extend to the ground surface in the north wall. Instead, it terminated between the south and north walls of the trench.

The lower main fault (labeled L in Figure 10, left) carries its largest apparent slip in the north wall of the Chushan trench, but it can be traced from the north wall into the south wall of the trench. The apparent dip increases with depth, reaching a maximum apparent dip of 27°. The maximum offset is approximately 2.9 m near the NE end of the north wall (Figure 10c, left). The same offset was measured along the upper branch of the near-horizontal part of the fault (Figure 10c, left). As the lower main fault flattens, it is expressed as at least three branch faults, subparallel to bedding (Figure 10, left). An offset of 1.7 m was measured along just the upper branch, labeled L_u (Figure 10c, left). The middle and lower branches, labeled L_m and L_l , respectively, were judged to have carried only small offsets. The trace of the upper branch L_u has a complicated, digitated form so the upper L_u and middle L_m branches may well have been dormant during the 1999 earthquake. The trace of the lower branch L_l appears to have been active during the 1999 earthquake based on the abruptly truncated roots; however, it likely has accommodated only a few cm of slip. Thus, it may well be that the offset on the lower fault decreases distally along the subhorizontal part of the fault trace in the north wall of the trench (Figure 10c, left).

Figure 10. The 2002 north and south walls of the Chushan trench. Stratigraphic units are described in Figure 9. (a) NE end of walls of Chushan trench. The contact between Unit 7 and Unit 8 is highlighted in white lines (photography by Wei-Hsiung Lin, Taiwan Central Geological Survey). (b) Map of same area of north wall (left). Map of same area of south wall (right). (c) Maps of fault traces. The apparent slips measured on the main faults are indicated with a number (in centimeter) in paired pentagons that show positions of offset markers on the faces.

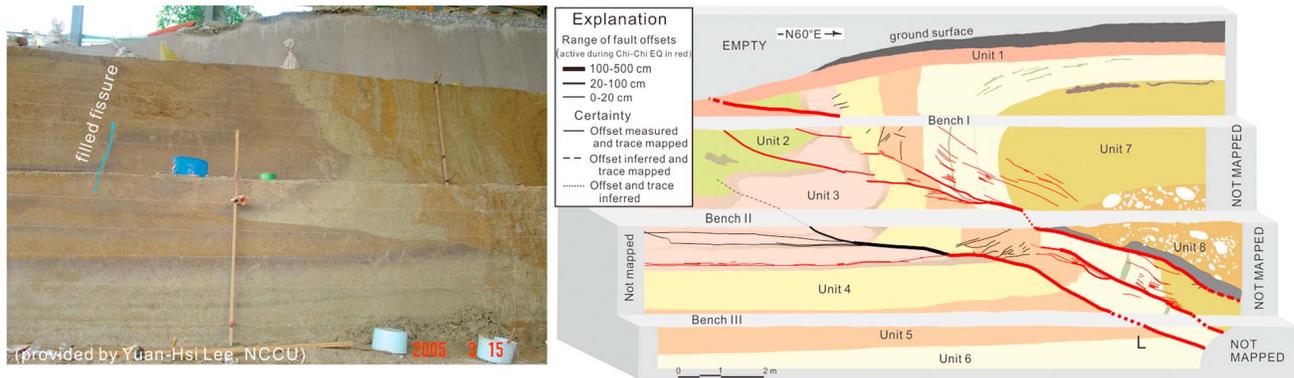
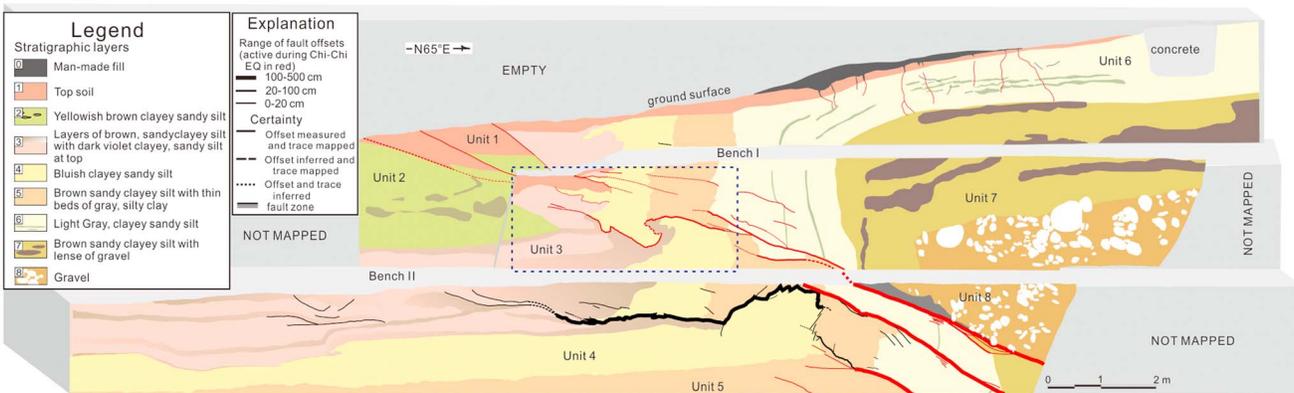
Figure 15. North walls of the Chushan trench in 2005 and 2012. (a) Photograph (left) and cross section of structures (right) of the 2005 north wall. The peeling project was ongoing while the photograph was taken. (b) Cross section of structures (up) and photograph (down) of the 2012 north wall. The dashed box circles an area which might be affected by post-earthquake effect attributed to an excavator (at middle left in Figure 8a).

likely associated with the flexure of the uppermost paleosol layer. This branch was dormant during the Chi-Chi earthquake because a steep filled fissure penetrated it without being displaced (Figure 15a, left).

Figure 15b shows the northern wall of the Chushan trench documented in 2012 located approximately 3 m north from the 2002 faces of the northern wall shown in Figure 10 (left) and approximately 2 m north from the 2005 faces shown in Figure 15a. In comparison with the 2002 exposure (Figure 10, left), the differences are obvious including the truncation of the anticline, the flexure of Unit 4 in the footwall of the lower main fault, and the stacking blocks of Units 3, 4, and 5 on the steep limb of the anticline (Figure S3). The truncation

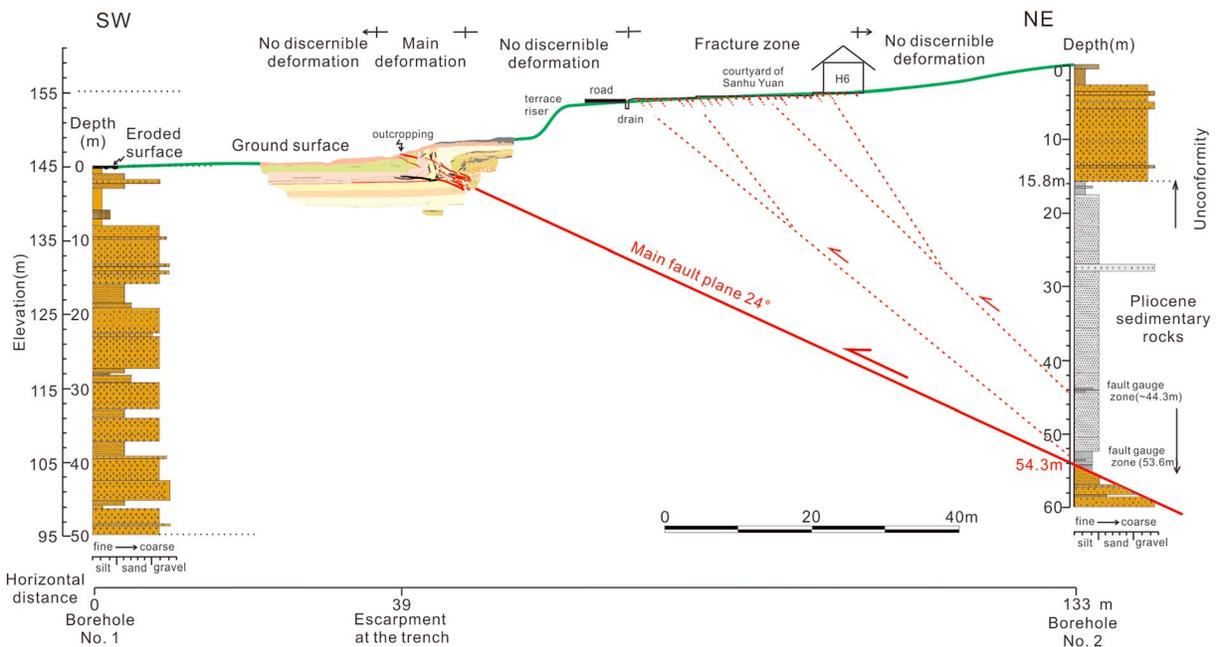
approximately 19.0. We think that the wider deformation zone in the hanging wall might result from slip on several branches of the dominant fault as shown in Figure 18. There are some arguments for that. The analysis on the structures in the Sanhu Yuan shows the consistency with thrusting in the Chushan trench, resulting from NE-SW compression. According to the model proposed by *Huang and Johnson* [2010], a value of ~19.0 for the ratio, w_{HW}/w_{FW} , corresponds to a dip angle of 13° for a dip-slip fault. Such a small angle does not seem reasonable for the geological setting at the Tanliwun area. Furthermore, there was a broad gap of ~22 m without any discernible deformation between the trench site and the Sanhu Yuan. *Chang et al.* [2015] defined the extent where the fault-induced surface deformation profile slope exceeds 1/150, i.e., ~0.38°, as affected width. As they indicated, the buildings that experienced an angular distortion of 1/150 would be expected to suffer considerable structural damage. The angular distortion is defined as the ratio of $\Delta S_{T(ij)}$ to L_{ij} , where ΔS_T and L_{ij} are differences in total settlement between any two points and distance between points i and j , respectively. According to their results (refer to Figure 28 in *Chang et al.* [2015]), the width of a fault-induced affected zone on the ground surface is predicted as ~24 m under a similar geological setting as the Tanliwun area, which is covered by 15.8 m thick unconsolidated sediment (Figure 18). This affected width, 24 m, is only about one third of the width, ~70 m, of the Chi-Chi deformation zone across the A-A' profile in Figure 2. We note that the experimental and numerical models of *Chang et al.* [2015] all started with a uniform-thickness overlaid material unlike the Tanliwun area, where the overlaid unconsolidated sediment varies significantly in thickness across the Chi-Chi deformation zone (Figure 18). In addition, shear planes and zones of fault gouge were observed in the Pliocene rocks of borehole no. 2 in the hanging wall of the dominant fault, which displaced Pliocene rocks over young alluvium layers. *Perrin et al.* [2015] suggested that the tip splay faults that branch off a main fault would form the most recent damage zone. Thus, we suggest that this wider deformation zone is attributed to the extra effect of slip on

Figure 18. Cross section of the Chi-Chi earthquake-induced deformation zone at Tanliwun. See location in Figure 2.

secondary faults branching from the dominant fault at several tens of meters depth. We also argue that those uncommon locations with a wider deformation zone in the footwall (for example, location G in Figure 2) might also result from slip on branches of the dominant fault.
