Survey Report: Dr16-8-11644; 2021/11/15

Benefits of Defining Geological Sensitive Zones in the Mitigation of Disasters Along Earthquake Fault Zones in Taiwan – The Case of Milun Fault

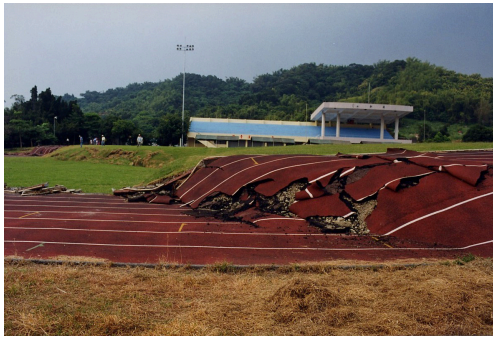
Fig. 1. Looking northward along the surface rupture at Kuangfu Middle School, around the central part of the Chelungpu Fault, there is steep scarp face on the hanging wall over the footwall (October 1999).

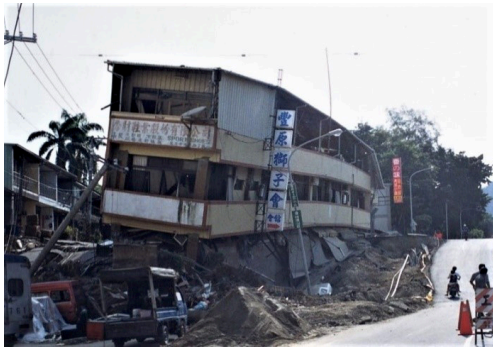
Fig. 2. Damaged buildings above the fault scarp near Chung-Cheng Park, along the northern part of the Chelungpu Fault (October 1999).

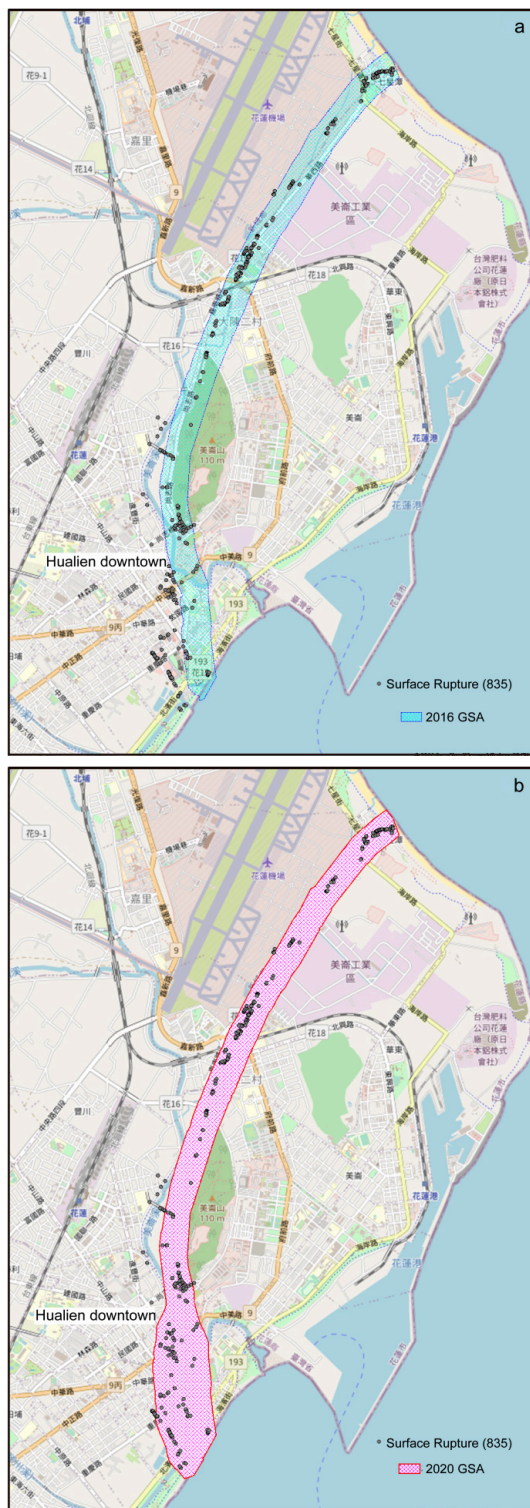
Fig. 8. Locations of surface ruptures from the 2018 Hualien Earthquake, indicated by circles, and the Milun Fault GSA. Map (a) is of the 2016 version of Milun Fault GSA. Map (b) is of the 2020 revised version.

After the 2018 Hualien Earthquake, the CGS conducted detailed investigations of the surface rupture characteristics and locations, as well as the domains of the flanks susceptible to fault action [27]. Two of the authors of this study were involved in these investigations. The surface ruptures induced by the Milun fault were identified based on their structural patterns, such as fracture modes, continuity, and trend. There were 835 surface rupture sites along the Milun Fault, with individual ruptures ranging from a few centimeters to tens of meters. Among them, 77% (647/835) were in the 2016 GSA and 93% (780/835) were in the 2020 GSA (Fig. 8 and Table 1).

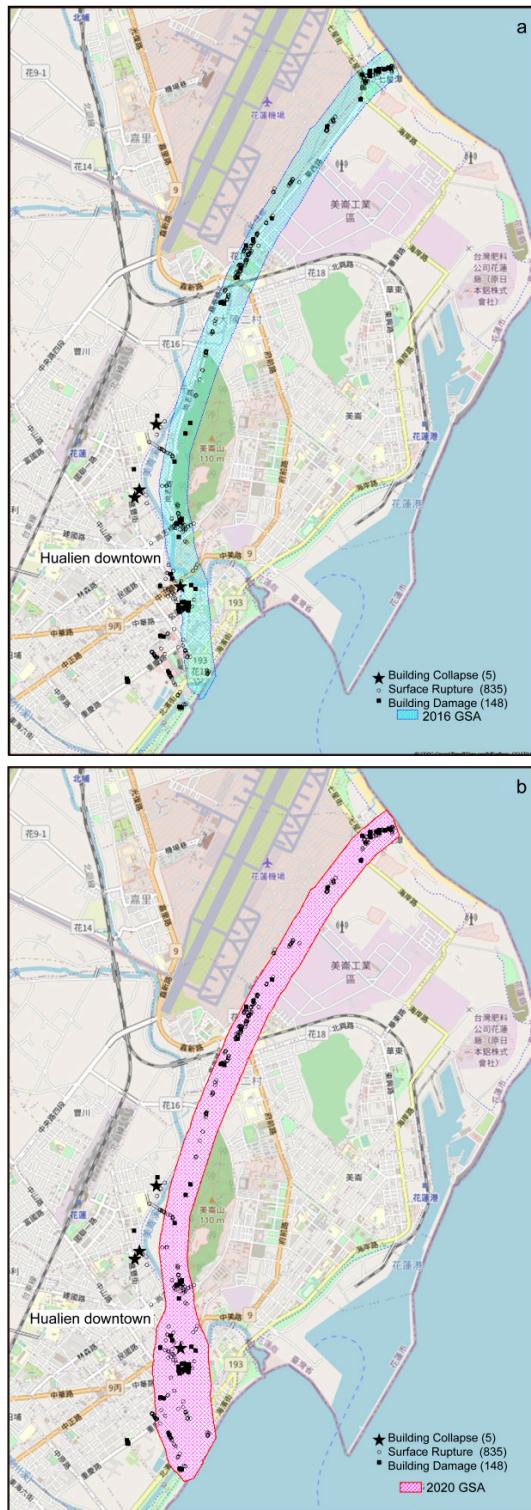
The CGS also investigated the distribution of damaged buildings. There were 148 lightly or moderately damaged buildings and, five collapsed buildings along the Milun Fault (Fig. 9). Among the damaged buildings, 68% (100/148) were within the 2016 GSA and 89% (132/148) were within the 2020 GSA (Table 1).

Some collapsed buildings were not within the GSA, but west of its western boundary (Fig. 9). Perhaps these collapses resulted from foundation failure due to liquefaction of the alluvial sediments along a paleochannel.

Fig. 9. Distribution of buildings damaged during the 2018 Hualien Earthquake. Map (a) is of the 2016 version of Milun Fault GSA. Map (b) is of the 2020 revised version.

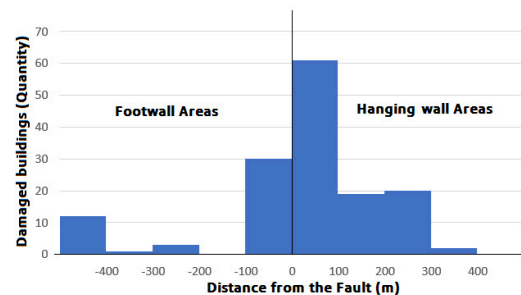
The surveys following the 2018 Hualien Earthquake showed that most of the surface ruptures and damaged buildings in Hualien City were within the Milun Fault GSA (**Fig. 9**). There was more damage on the hanging wall than on the footwall, and toward the fault line (**Table 2** and **Fig. 10**).

Fig. 10. Number of damaged buildings versus distance from the surface fault trace for the areas on the hanging wall and the footwall along the Milun Fault. Note that the damage to buildings at the far end of the footwall was caused by ground liquefaction and shaking.

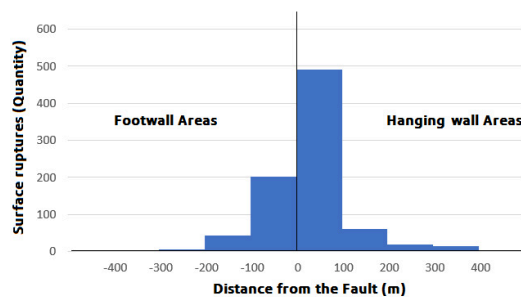
This distribution pattern was compatible with the occurrence of surface ruptures (**Table 3** and **Fig. 11**). These findings revealed that GSAs of active faults are necessary and crucial for protecting human habitats from earthquake disasters, or at least mitigating the risk of severe damage.

**Fig. 11.** Number of surface ruptures versus distance from the surface fault trace for the areas on the hanging wall and the footwall along the Milun Fault.
