碩士論文

**Characteristics of the Chihshang Fault at Tapo-
elementary school area, Eastern Taiwan**

June, 2020

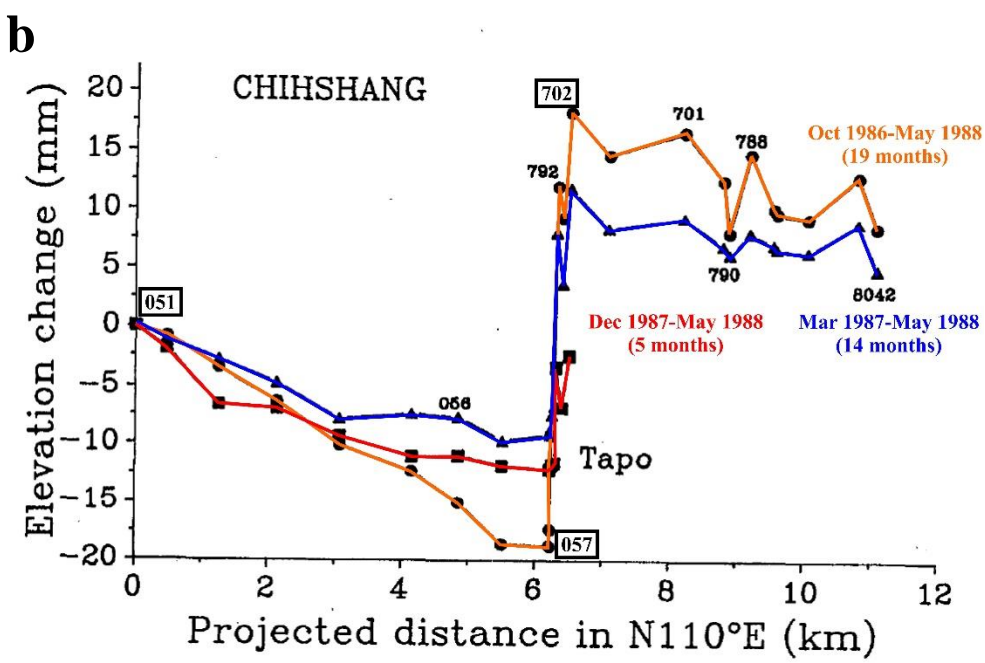
Figure 1.4 Results of leveling measurement at Chihshang (modified from Yu & Liu, 1989). (a) Leveling route at Chihshang. Red dashed-line indicates the Trace of the Chihshang Fault (adapted from Jiang et al., 2012). (b) Elevation changes of bench marks relative to BM 051 during 1986 to 1988 (modified from Yu & Liu, 1989).

fractures were kept developing (Angelier et al., 1997). In the 1980s, Yu and Liu (1989) reported evidence of vertical active creep of the Chihshang Fault based on the leveling data from 1986 – 1988 (Fig. 1.4). Compared to the morphology, the result of the leveling study was consistent with the major geomorphic scarp near Chihshang township. The significant uplift rate, of about 21 mm/yr, was observed between two benchmarks, each of which is located on the west and east side of the geomorphic scarp at Tapo.

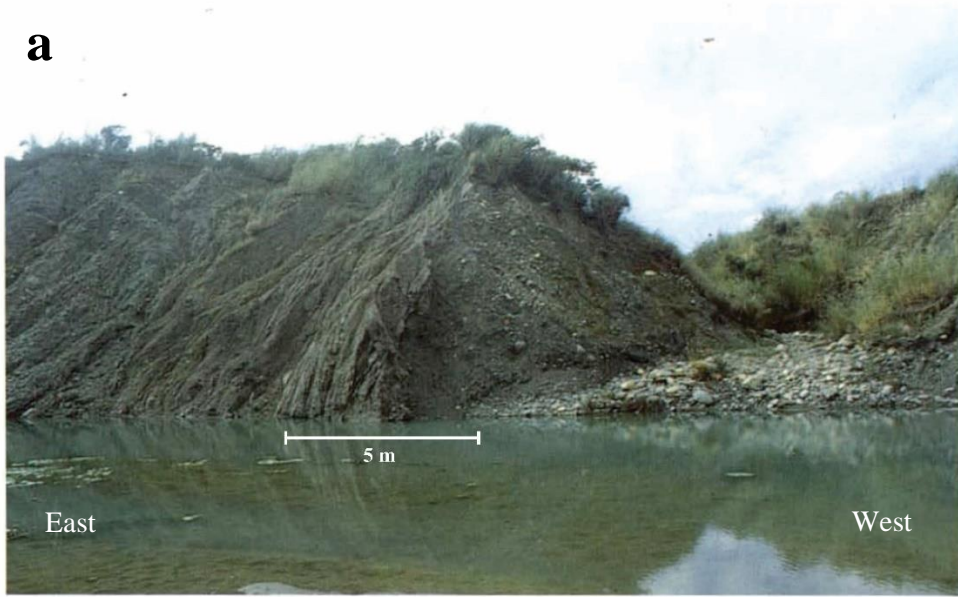
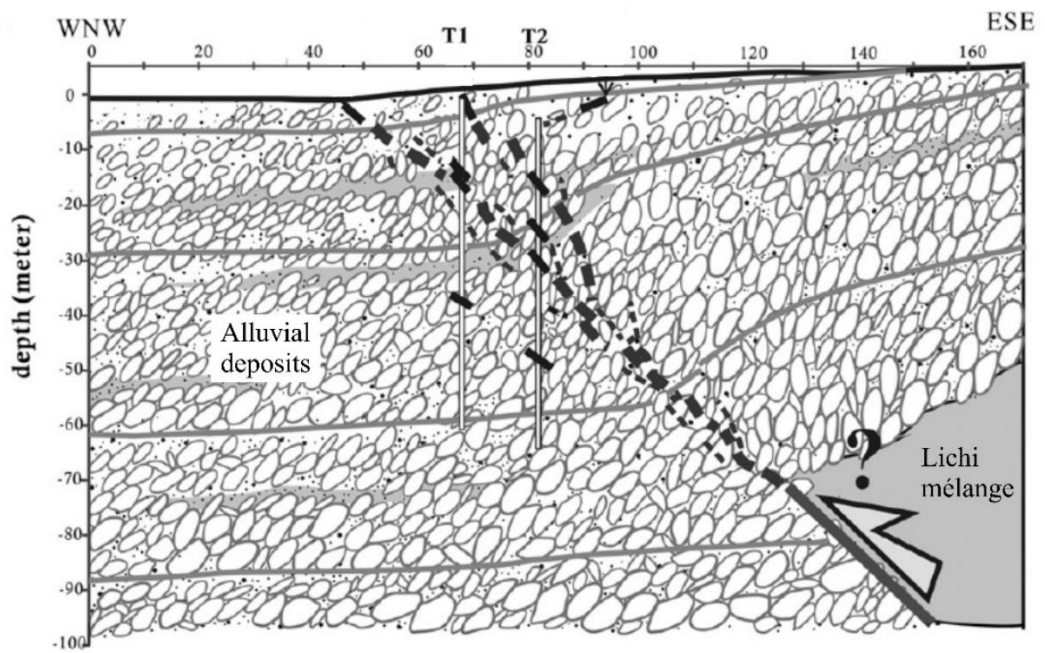
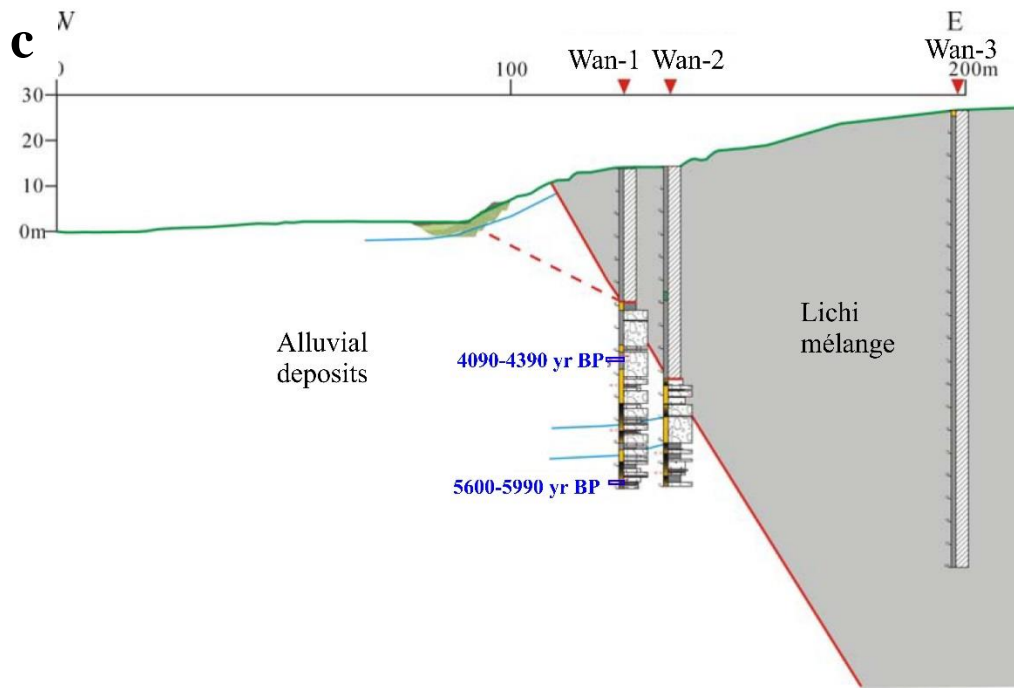
Figure 1.5 Chihshang Fault architecture at three research locations (Fig. 1.2). (a) Outcrop of Chihshang Fault at Fuli (after Yu et al., 1994). The Lichi mélange, in the east side, thrusts over the Holocene deposits, in the west side. (b) Chihshang Fault architecture at Chinyuan site (from Mu et al., 2011). (c) Chihshang Fault architecture at Wan-an site (after Chen, W.S., 2008).

In Chinyuan, Mu et al. (2011) drilled three boreholes. Based on the analysis of the borehole cores, they observed three-branch faults of the Chihshang Fault in the alluvial deposits with different dip angles. By comprehensive geodetic analysis and fault kinematics, the frontal branch fault of Chihshang Fault has a dip angle of 34° E – 42° E, which corresponds to the surface main geomorphic escarpment (Mu et al., 2011) (Fig. 1.5b).

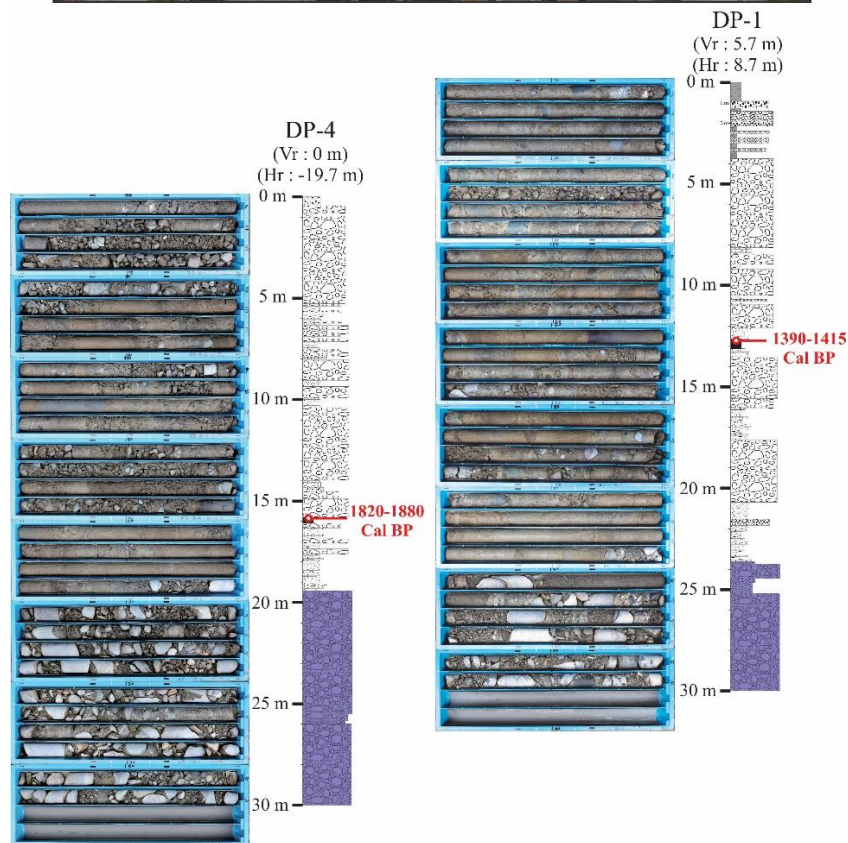
Figure 1.7 Boreholes at Tapo Elementary School (TCGS, 2018). (a) Oblique view of Tapo Elementary School (Tapo ES). Red dashed-line indicates major geomorphic scarp. White circle with label indicates the borehole location. (b) Core image along with the core logs. Vr indicates the relative elevation of the upper end of the borehole with respect to the surface level of the Tapo ES yard. Hr (+) indicates the relative horizontal distance of the borehole from the toe of the major geomorphic scarp to the east. Hr (-) indicates the relative horizontal distance of the borehole from the toe of the major geomorphic scarp to the west. Red label indicates the calibrated dating data from the organic sediment that was obtained from the core.

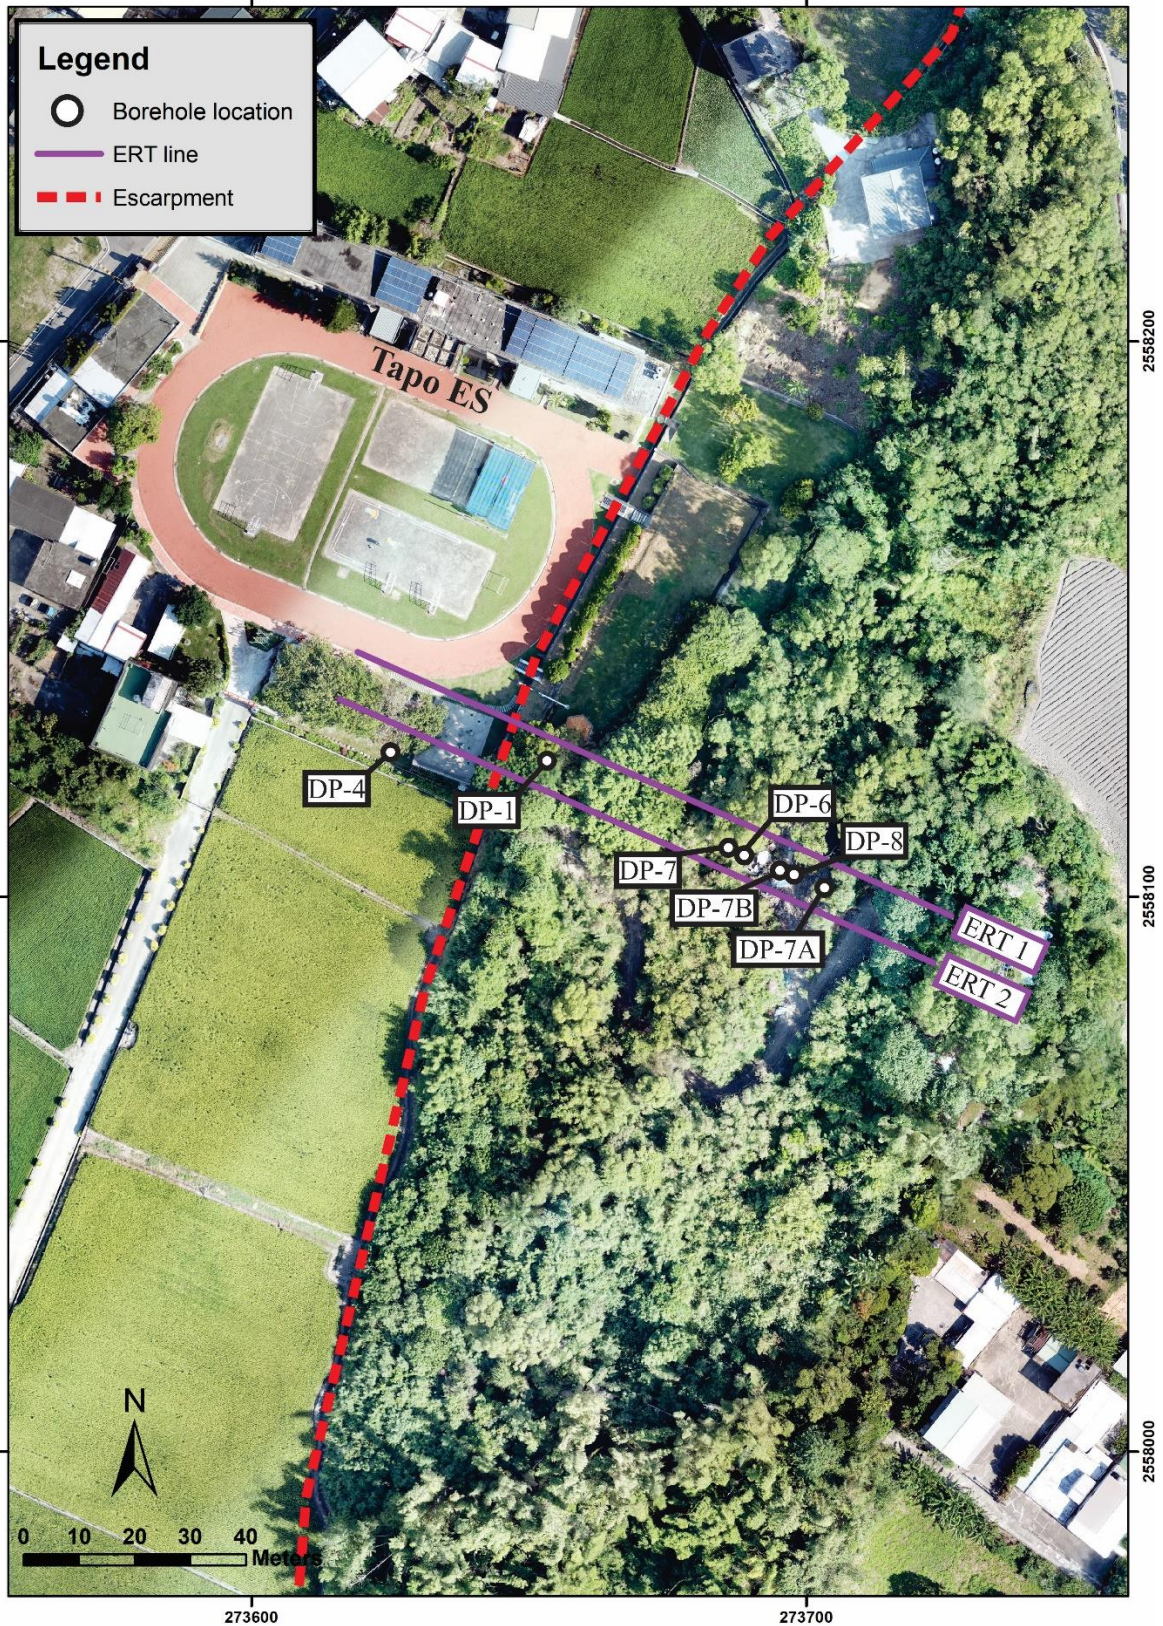
Figure 2.1 Bird view image of research area along with configuration of Electric Resistivity Tomography (ERT) survey line and boreholes.

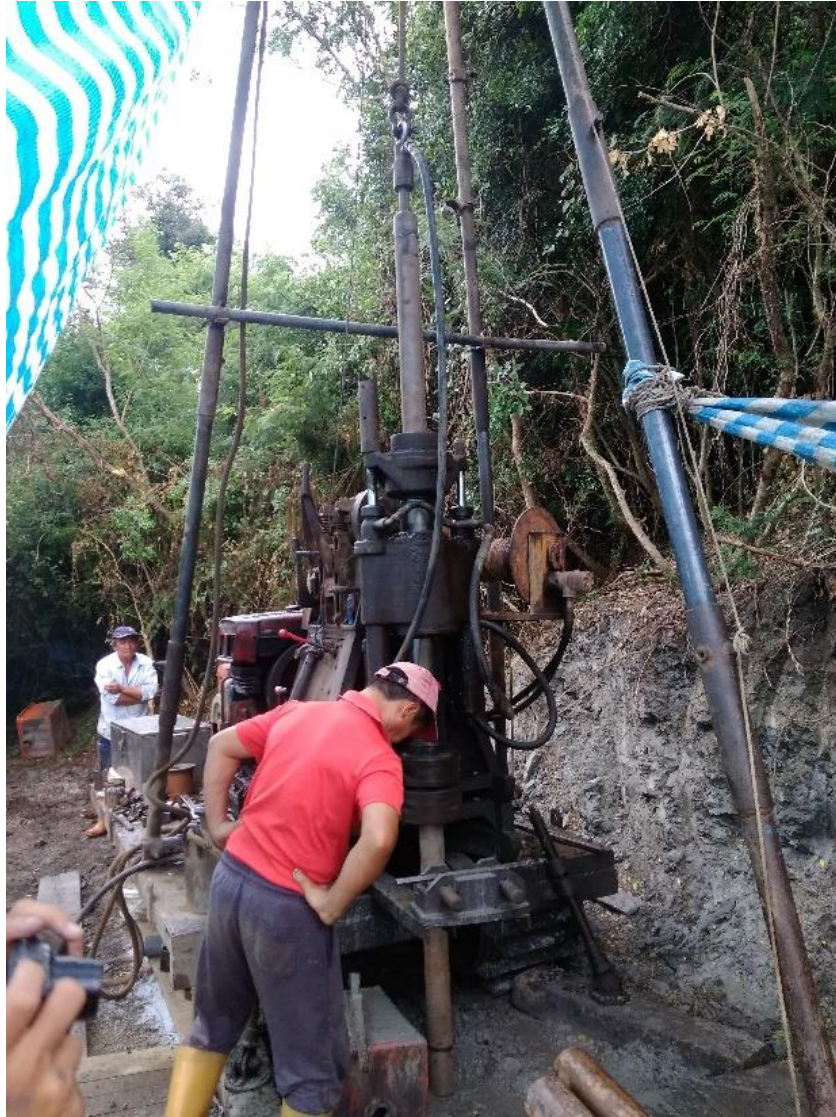
Figure 2.3 Photograph of the operation of the drilling machine.

We hired two experienced engineers to operate the drilling machine and to help us collect the cores (Fig.2.3). The drilling process was time-consuming because it was dependent on the weather condition and type of subsurface material. Each core was taken out from the borehole in every one-meter length by the drilling machine. This core was taken out in wet conditions, so we had to wait a few minutes until the core was a little dry before did further step of analysis. After the drying, we scratch tiny part the core surface to clean the core from the dirt that might adhere during the core taking process. Based on core observation, we generally classified three distinct lithologic units: the Lichi mélange, the alluvial layer which consist of intercalation between the andesitic gravel layer with the fine to very fine sandy layer, and the alluvial metamorphic gravel layer.

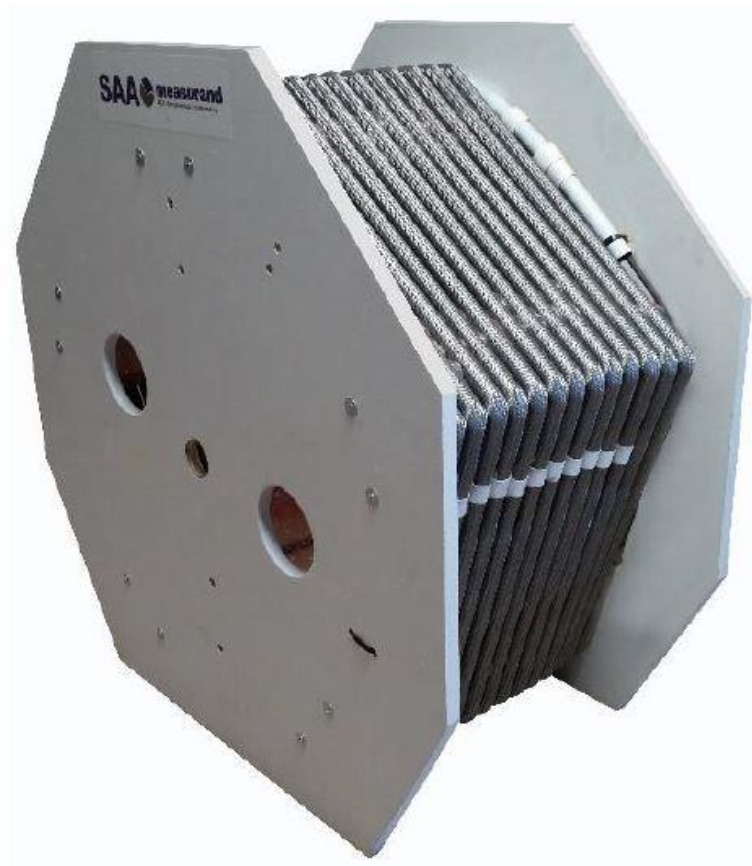
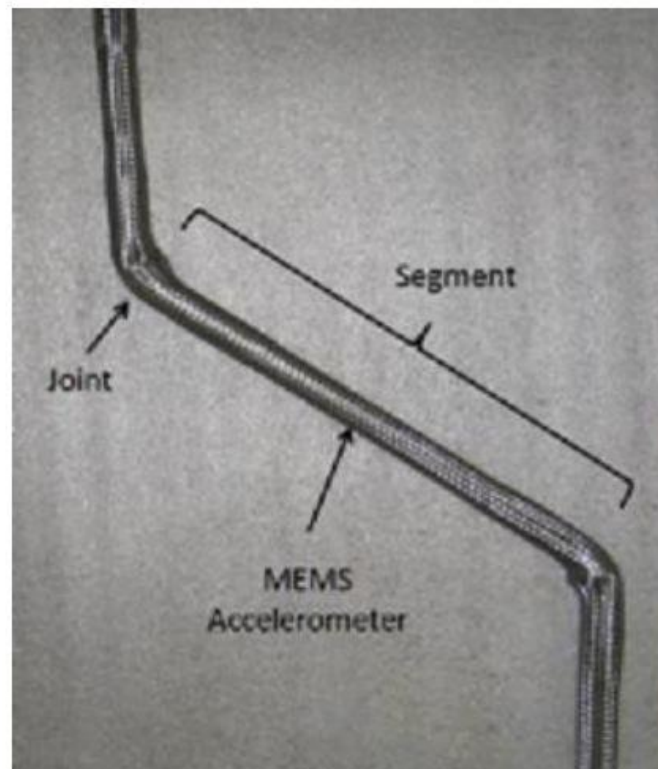
Figure 2.4 Image of SAAF inclinometer (Measurand Company).

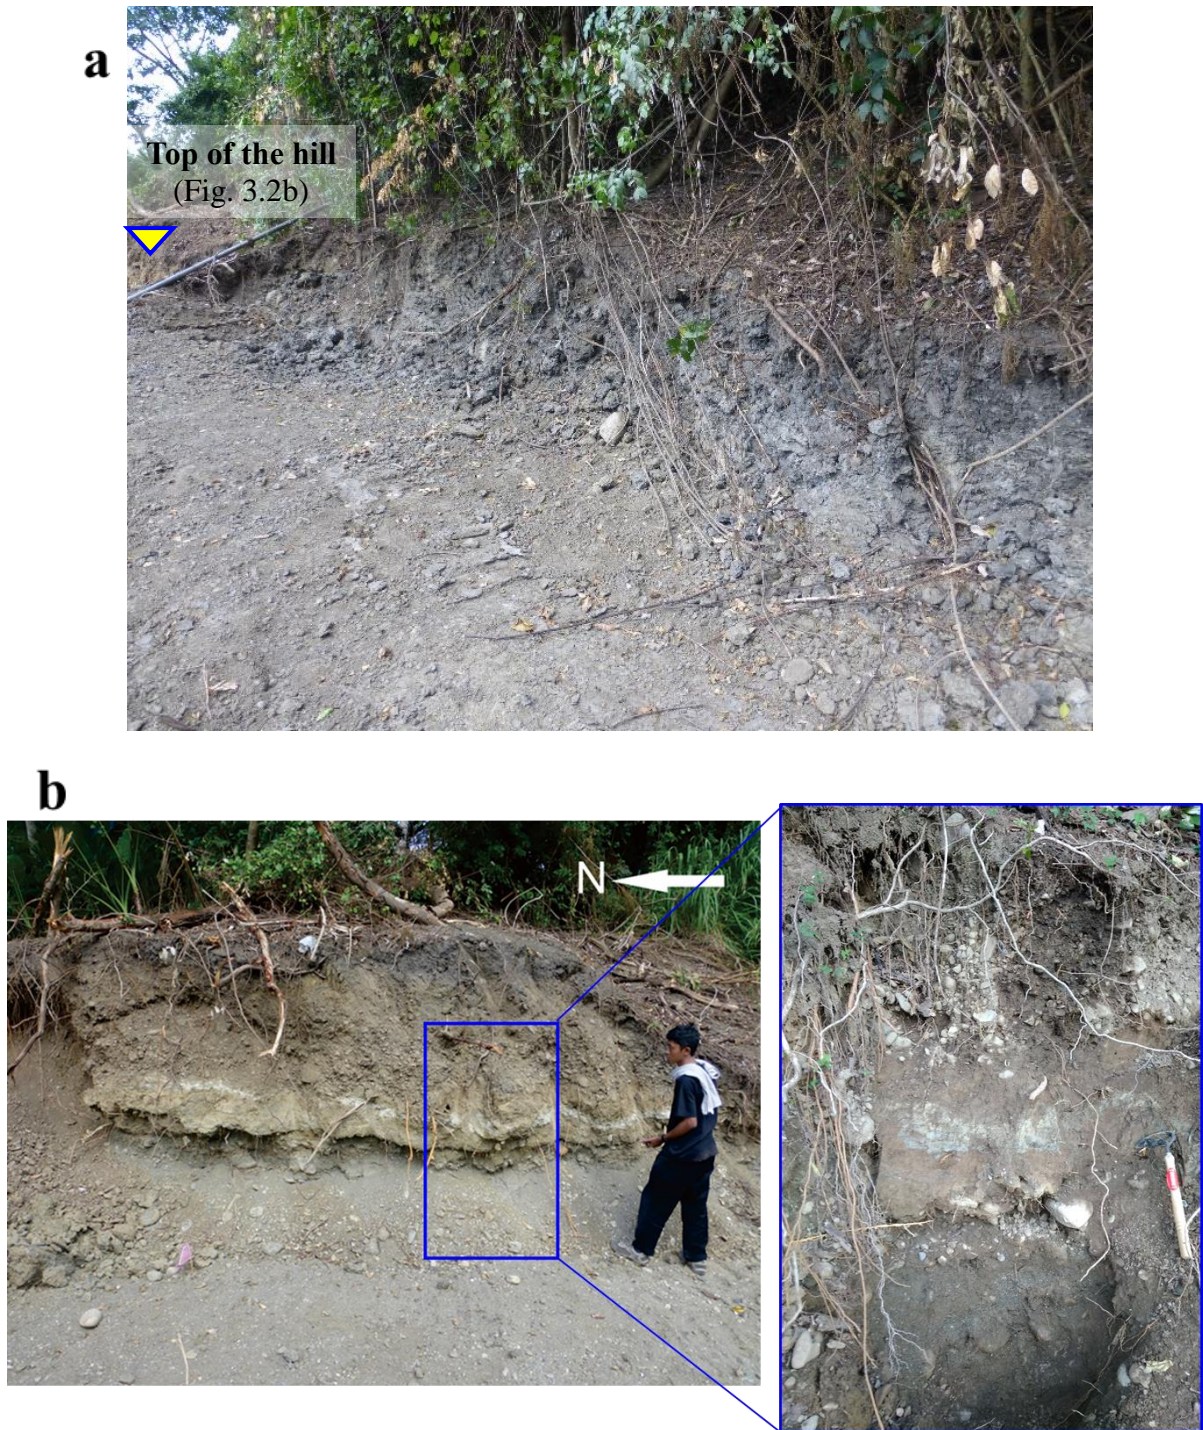
Figure 3.2 Photograph of outcrop at the hill area eastward from Tapo ES. (a) The *mélange* without internal strata present on the outcrop as shown in this figure. (b) Photograph of outcrop on the top of hill (left) along with the close-up view of the outcrop (right).

During the field survey, we did some observations around this hill. This area mainly consists of *mélange* material with fragments of sandstone and andesitic rock (Fig 3.2a). Near the peak of the hill, we observed an obvious outcrop of the sediment deposits (Fig 3.2b). These deposits are alluvial layers sourced from the Coastal Range, which are the andesitic gravelly layer and fine-grained sand layer (Fig 3.3). The width of this alluvial layer and the fine-grained sand layer is about 1 m and 0.5 m, respectively.

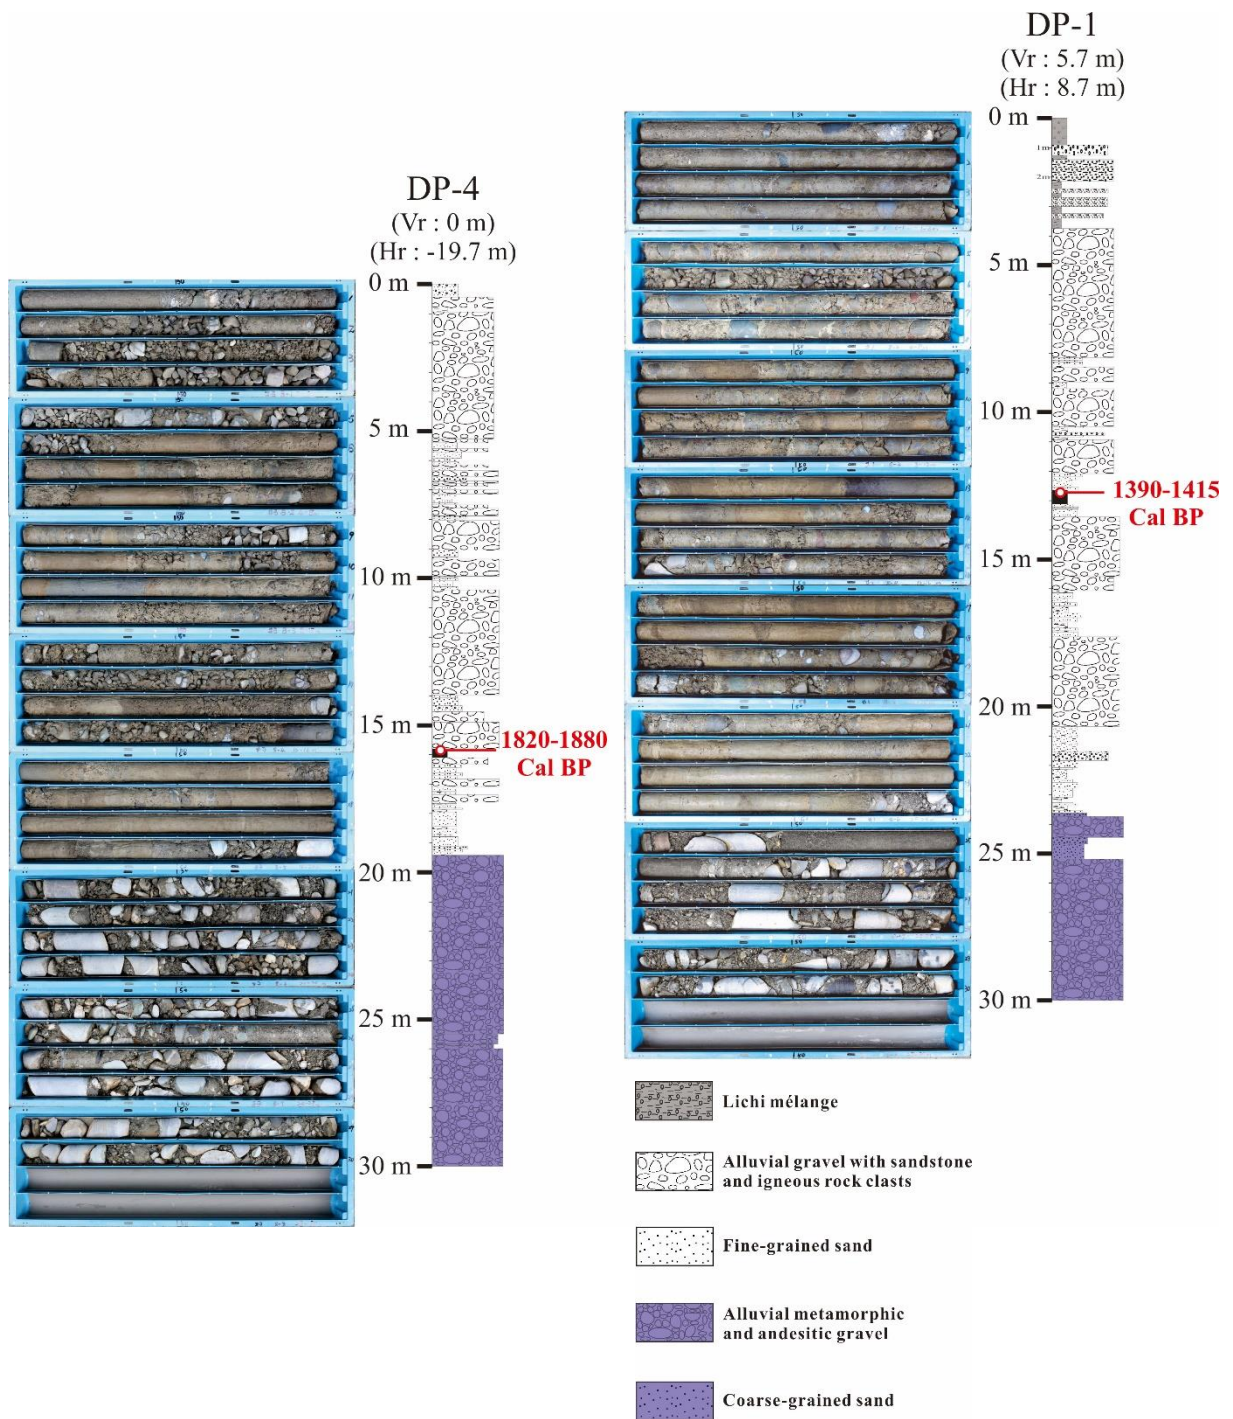
Figure 3.4 Photograph of the core and architecture of the core logs DP-1 and DP-4. Vr indicates the relative elevation of the upper end of the borehole with respect to the surface level of the Tapo ES yard. Hr (+) indicates the relative horizontal distance of the borehole from the toe of the major geomorphic scarp to the east. Hr (-) indicates the relative horizontal distance of the borehole from the toe of the major geomorphic scarp to the west. Red label indicates the dating results.

We observed three distinct lithological units: Lichi *mélange*, alluvium layer sourced from the Coastal Range, and alluvial gravel sourced from the Central Range (Fig 3.4, Fig 3.5, Fig 3.6, Appendixes: from A.1 to A.20). The Lichi *mélange* consists dominantly of mud matrix with fragments of sandstone and andesitic (Fig 3.7). These fragments have varied size, shape, and fracture density.

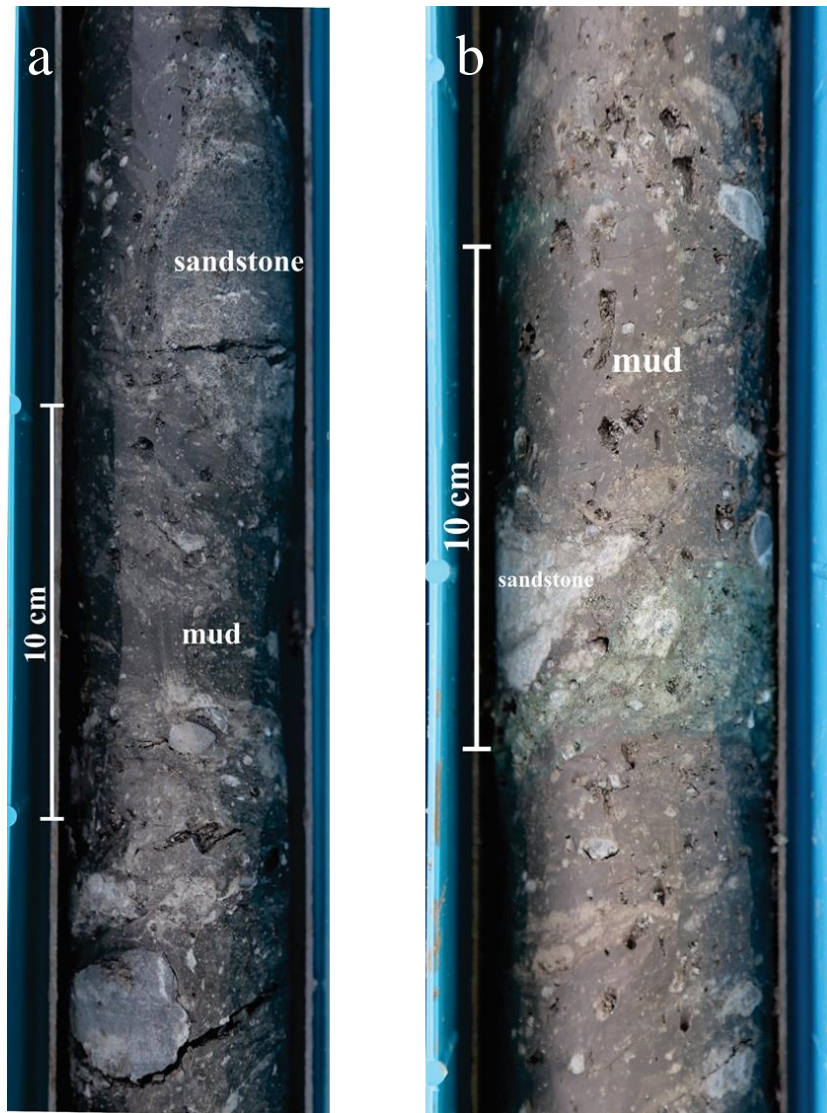
Figure 3.7 Close view of mélangé material. (a) Rock core of DP-7 at depth 8.5 – 8.7 m. (b) Rock core of DP-6 at depth 5.4 – 5.6 m.

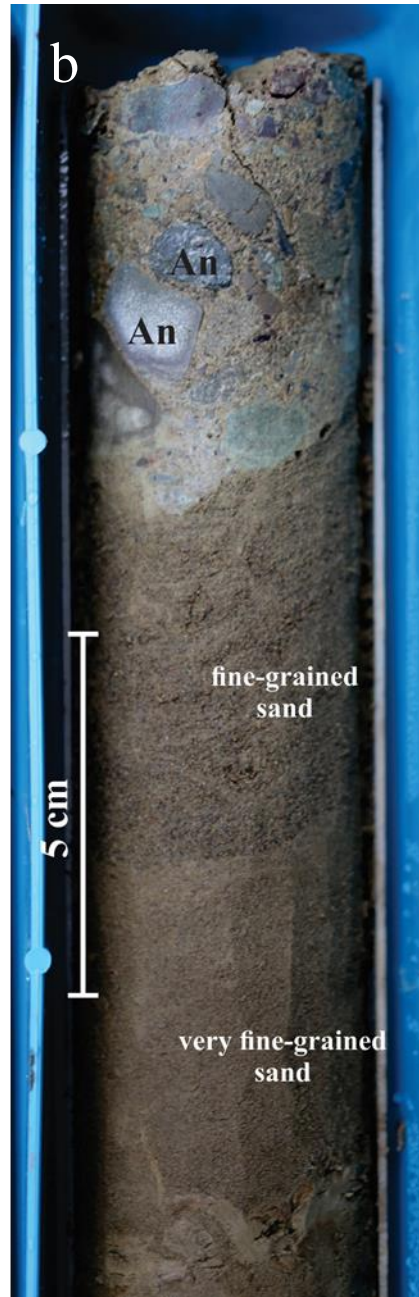
Figure 3.8 Close view of alluvium sourced from the Costal Range (AlCoR). Label “An” indicates the andesitic pebble. (a) Rock core of DP-7B at depth 15.5 – 16.5 m. (b) Rock core of DP-1 at depth 12– 12.3 m.

The alluvium sourced from the Coastal Range is quite obvious to be observed since this layer has a bright brown color. This layer consists of sandstone gravel and andesitic gravels (Fig 3.8a). In general, these gravels have an angular to subangular shape with a diameter range of about 5-10 cm. The fine-grained sand layer with the various thickness (a few centimeters to 5 meters) were observed at the particular depth and interlayered with the alluvium gravel sourced from the Coastal Range (Fig 3.8b).

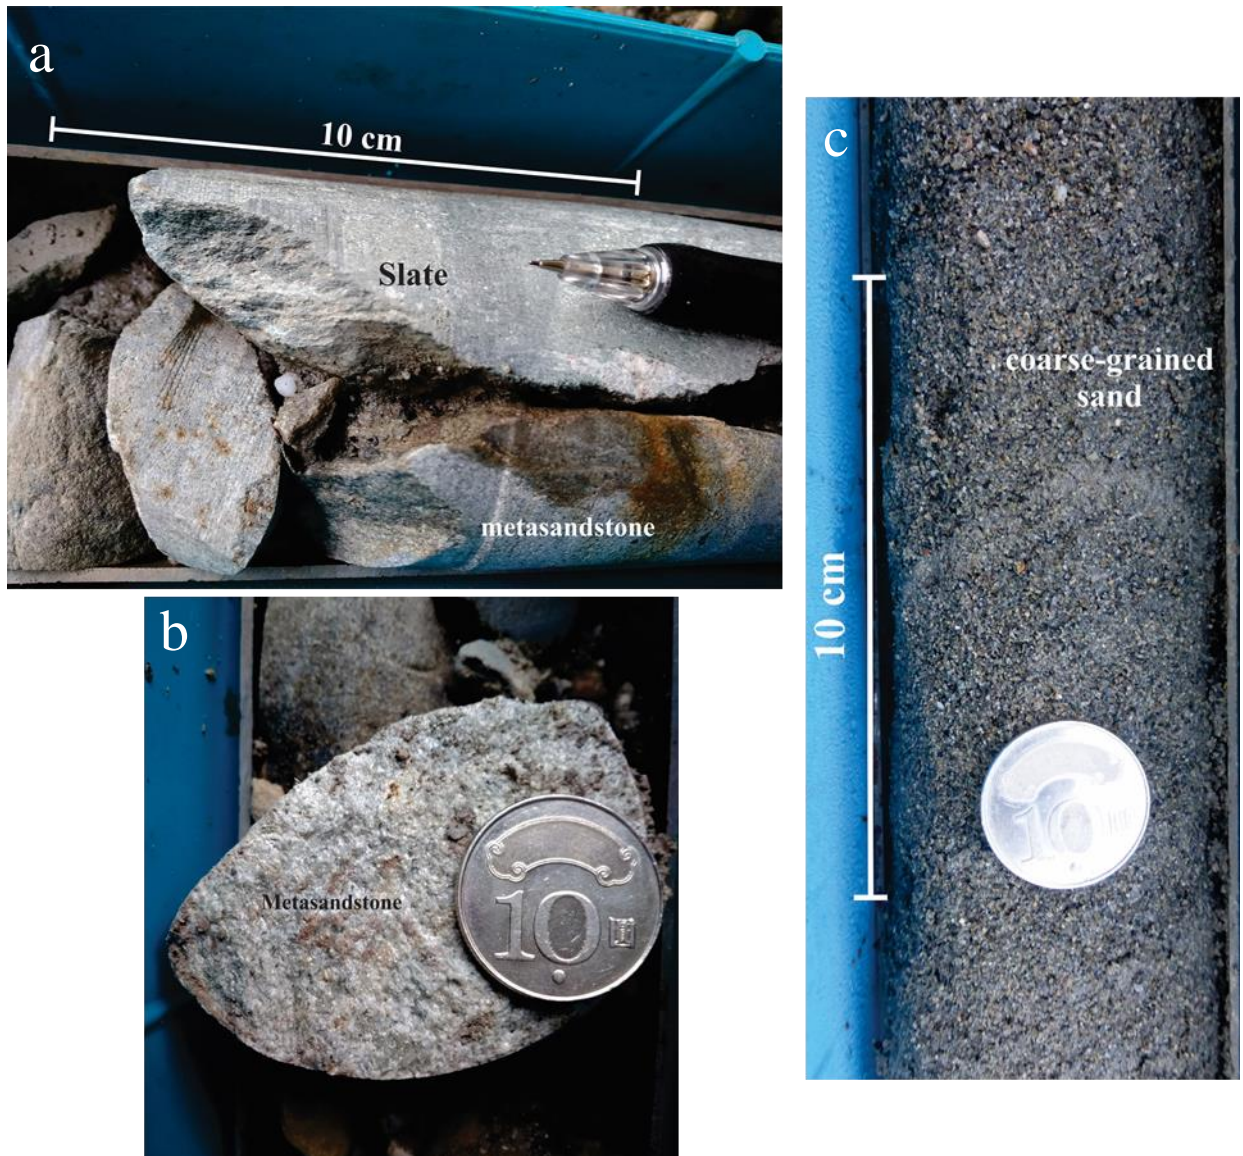
Figure 3.9 Close view of alluvium sourced from the Central Range (AlCeR). (a) Rock core of DP-8 at depth 29.8 – 30 m. (b) Metasandstone of AlCeR. (c) Rock core of DP-7B at depth 44.3 – 44.4 m.

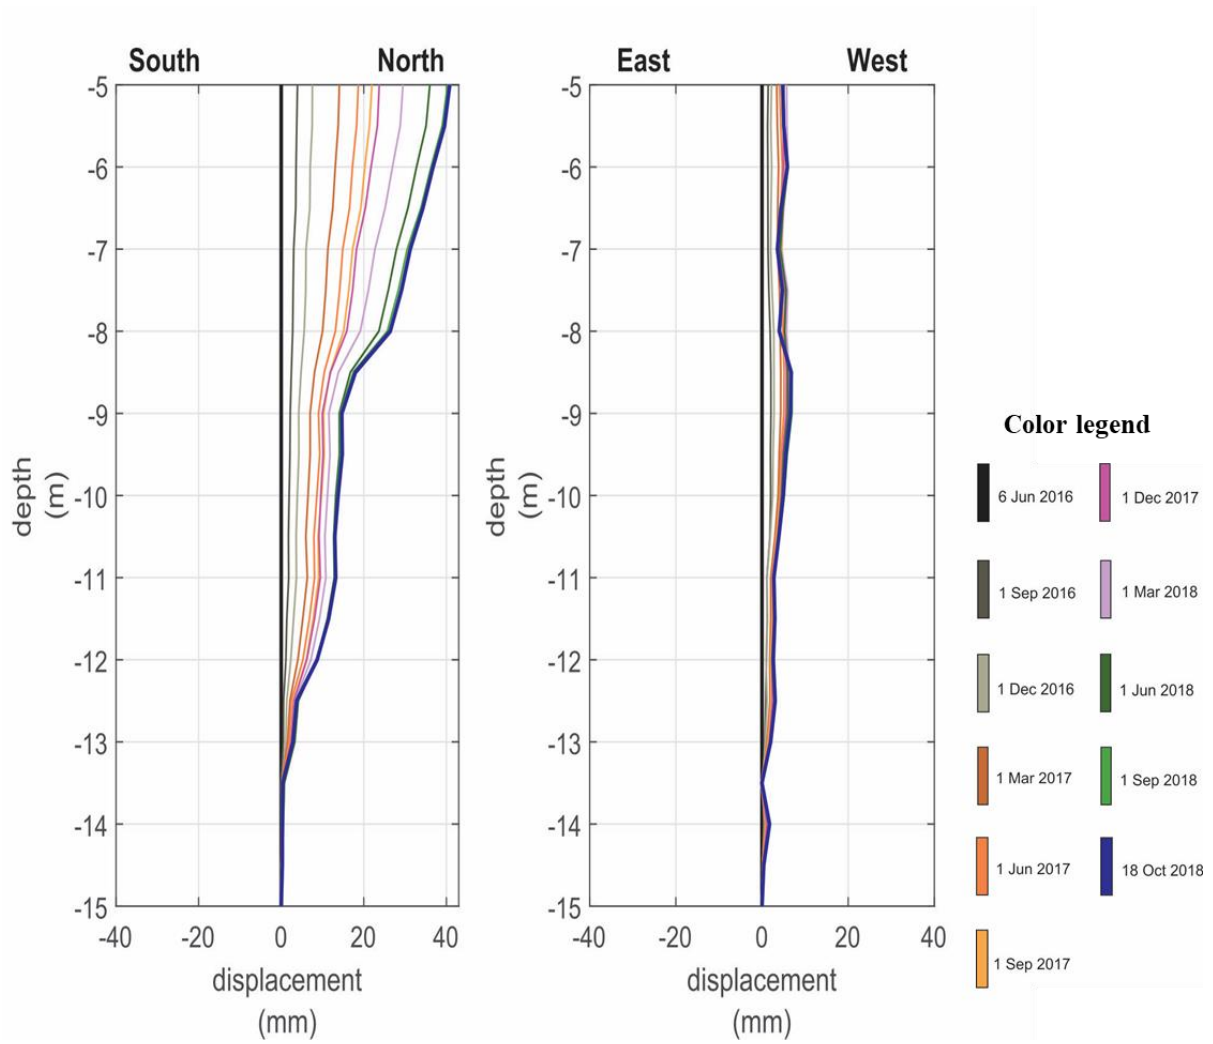
Figure 3.10 Incremental displacement graph of inclinometer data in borehole 7.

In DP-7, the displacement was oriented to the North-Northwest with the cumulated displacement of the upper point of about 40 mm within two years (Fig. 3.7). We observed the significant increase of the displacement magnitude at depth of from 9 m to 8 m and 13.5 m to 12 m. Meanwhile, at depth of above 8 m, the displacement magnitude tended to be gradually increasing upward. This phenomenon might correspond to the presence of the shear

deformation within the corresponding depth. At the bottom depth, of about 13.5 m to 15 m, no significant displacement was recorded.

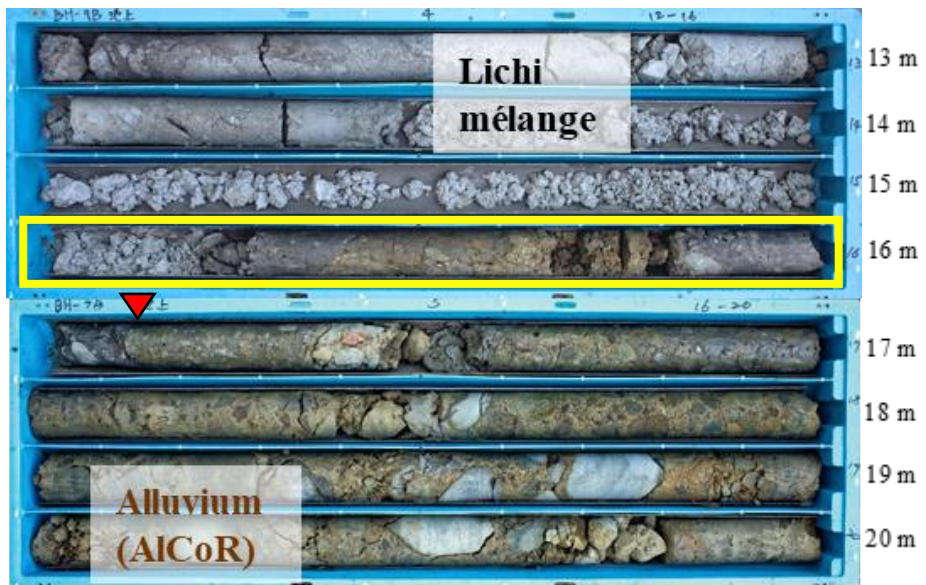
Figure 4.3 Photograph of the rock core of DP-7B at depth of 12 m to 20 m. Red triangle points the lithological contact. Yellow rectangular highlights the mixed zone near the lithological contact between Lichi mélange and Holocene deposit.

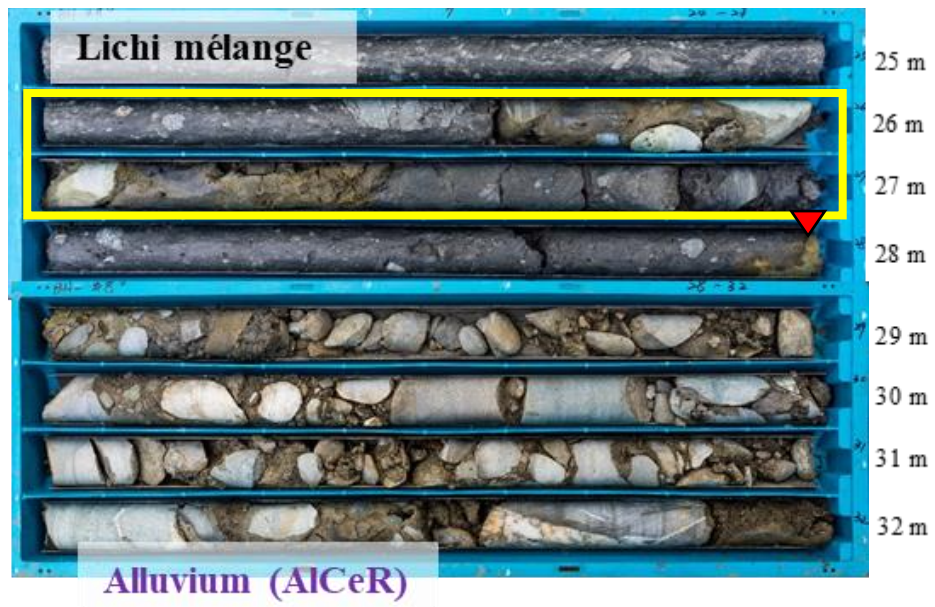
Figure 4.4 Same as Figure 4.3 for DP-8.

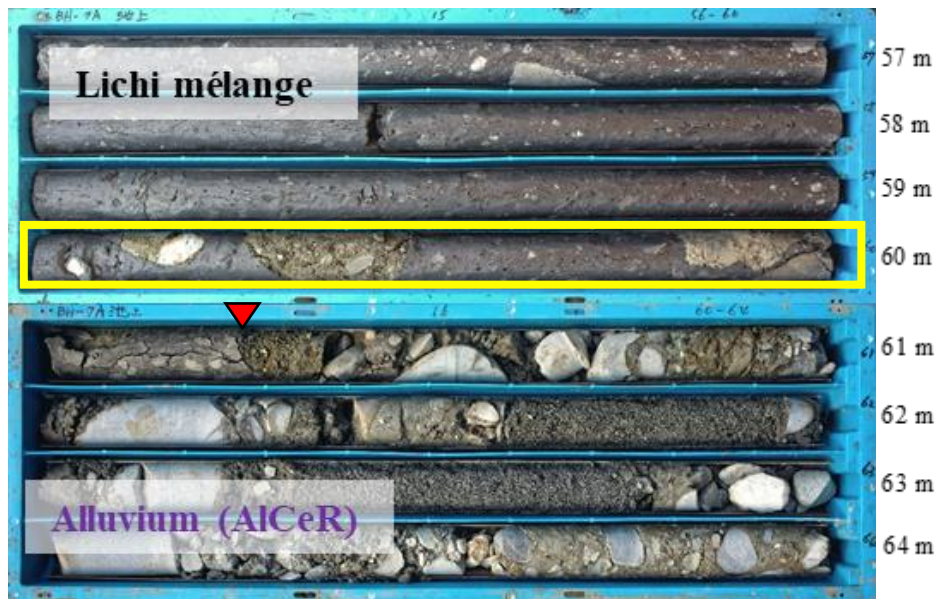
Figure 4.5 Same as Figure 4.3 for DP-7A.

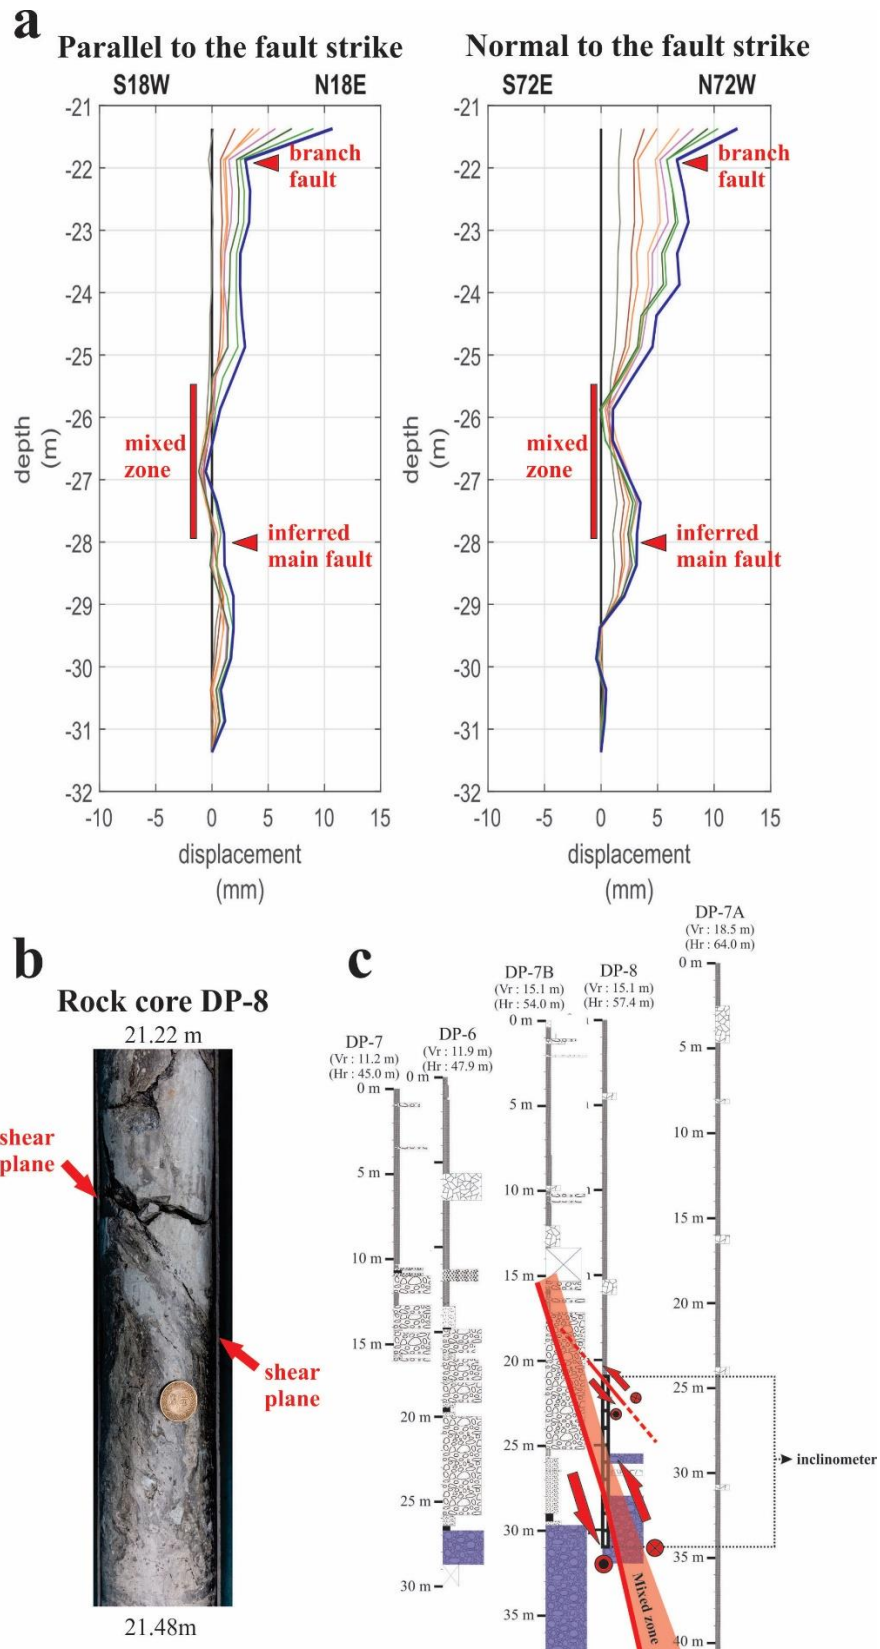
Figure 4.6 (a) Incremental displacement graph of inclinometer data in DP-8 by projecting to fault axis (N18°E to S18°W) along with interpretation label based on core observation. (b) Close view of shear plane in rock core DP-8. (c) Core logs along with the trace of main fault, branch fault, and mixed zone.

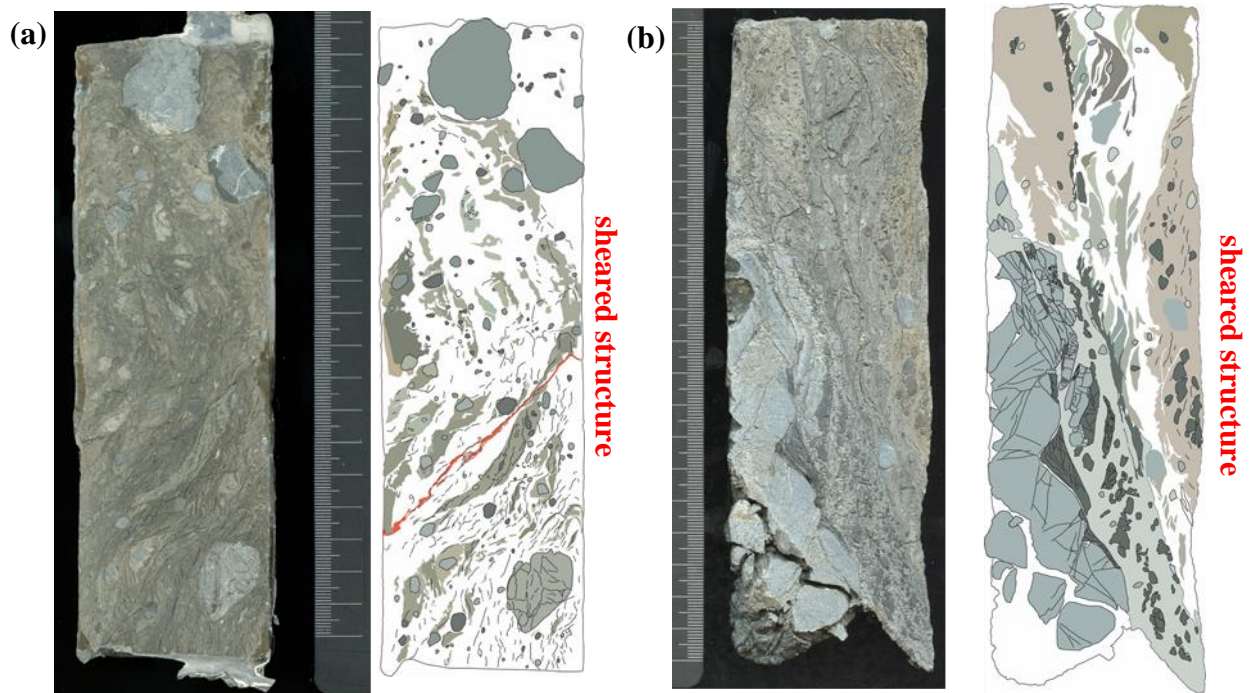
Figure 4.8 Photograph of half-cylindrical core along with the sketch of the mud structure in borehole DP-8. Colorless area (white) indicates the mud material. Colored area indicates fragment that embedded in the mud body. Black-line indicates crack. (a) DP-8 core sample at depth of 11.8 m to 12.0 m. (b) DP-8 core sample at depth of 15.0 m to 15.2 m.

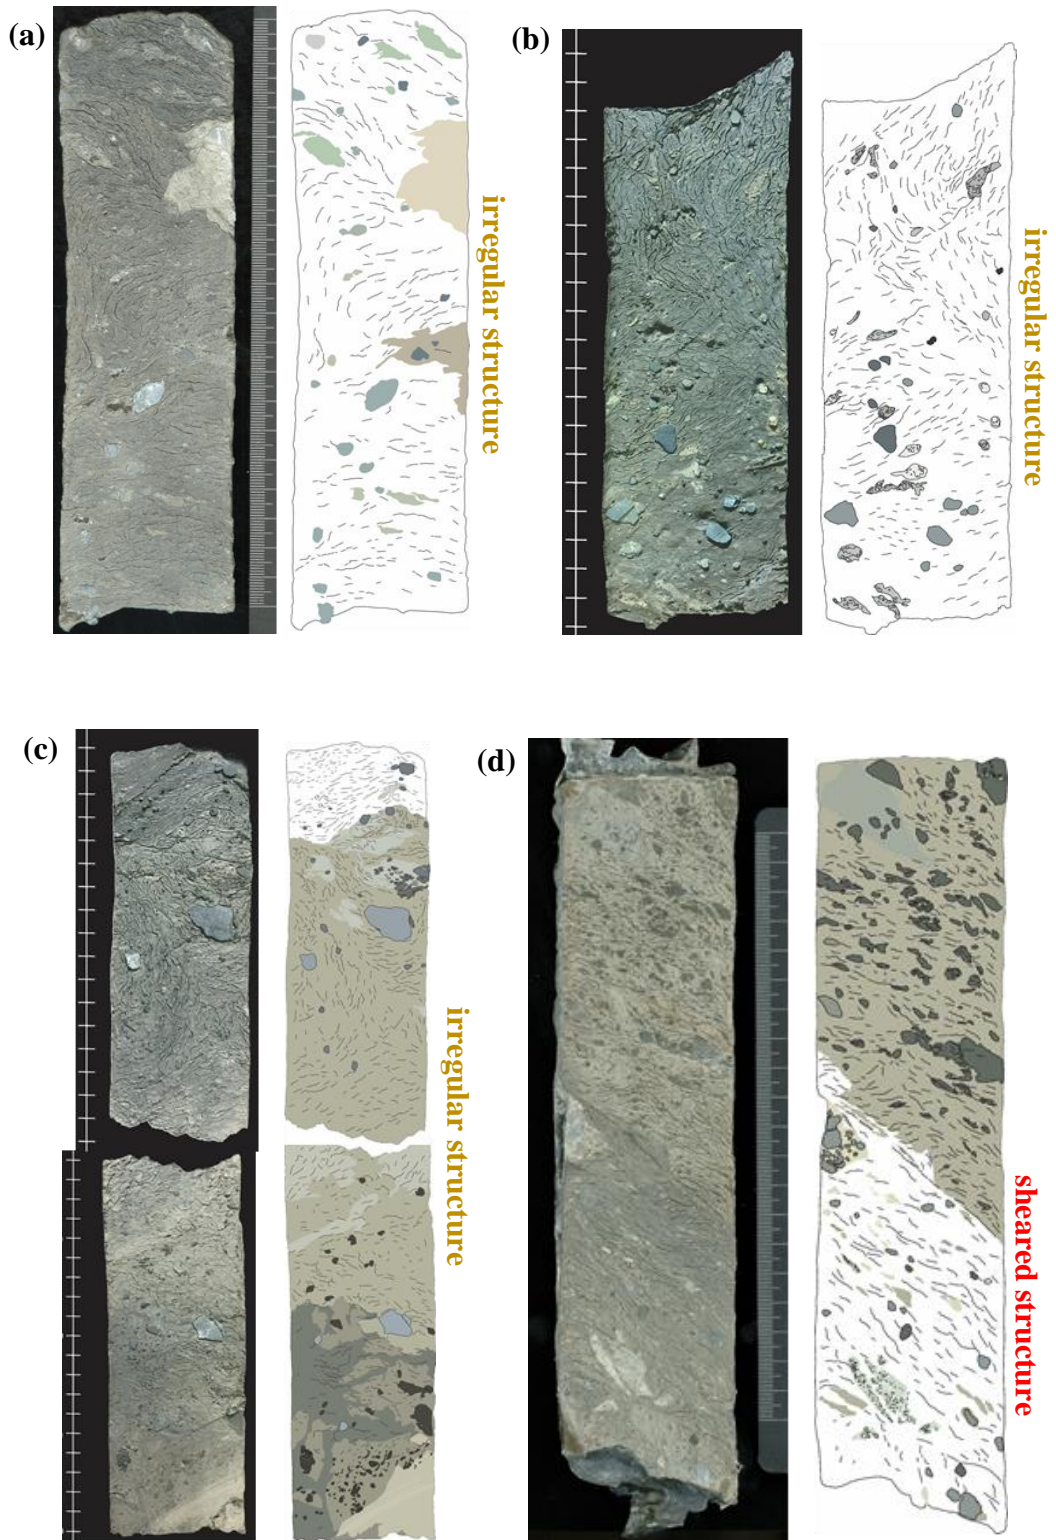
Figure 4.9 Same as Figure 4.8. (a) DP-8 core sample at depth 7.8 m to 8.0 m. (b) DP-8 core sample at depth 8.21 m to 8.4 m. (c) DP-8 core sample at depth 8.65 m to 9.0 m. (d) DP-8 core sample at depth 9.0 m to 9.25 m.
