碩士論文

**Characteristics of the Chihshang Fault at Tapo-
elementary school area, Eastern Taiwan**

June, 2020

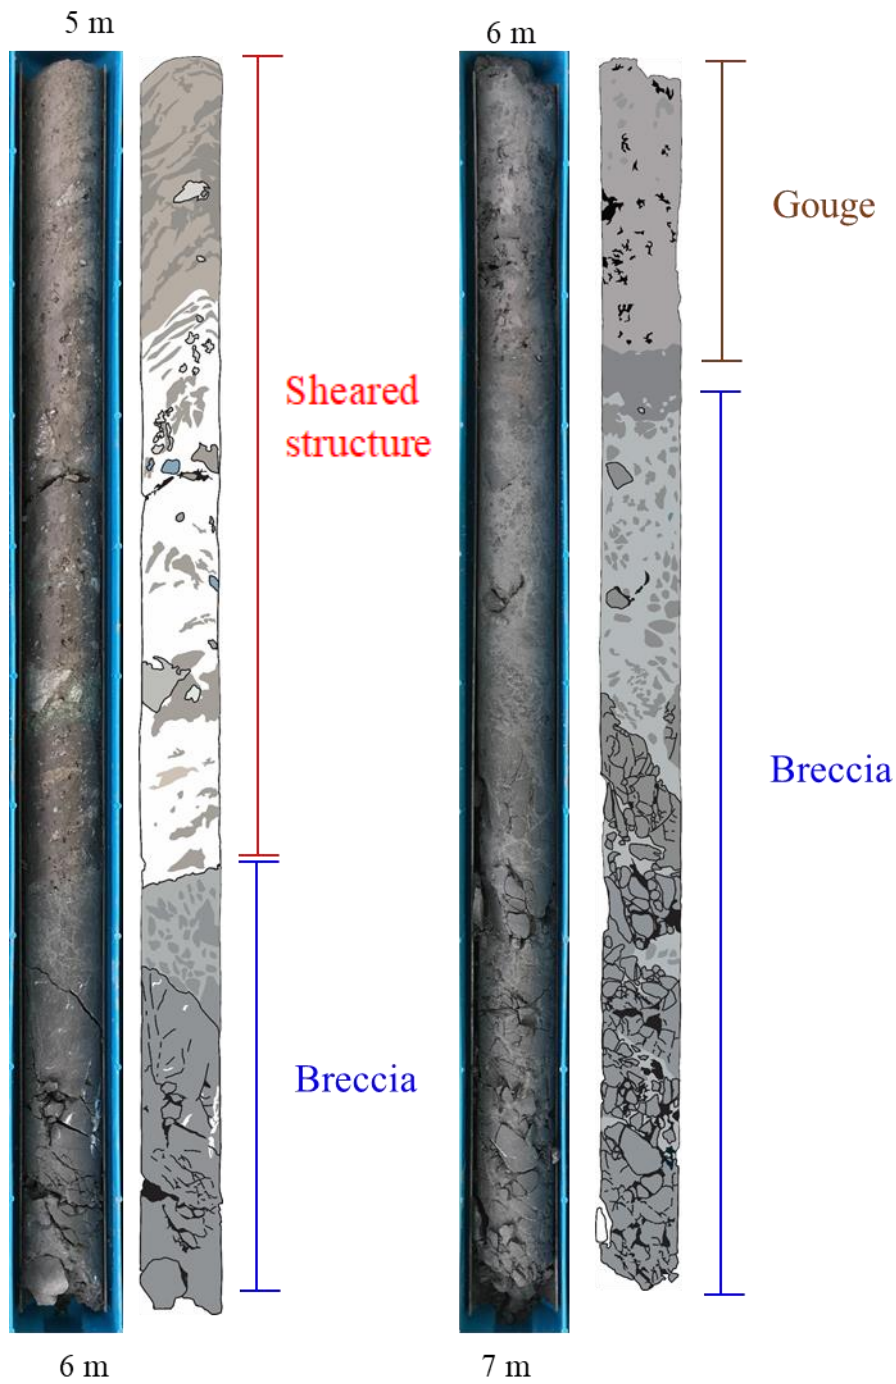
Figure 4.11 Photograph of core along with the sketch of the mélangé body in borehole DP-6. Colorless area (white) indicates the mud material. Colored area indicates fragment that embedded in the mud body.

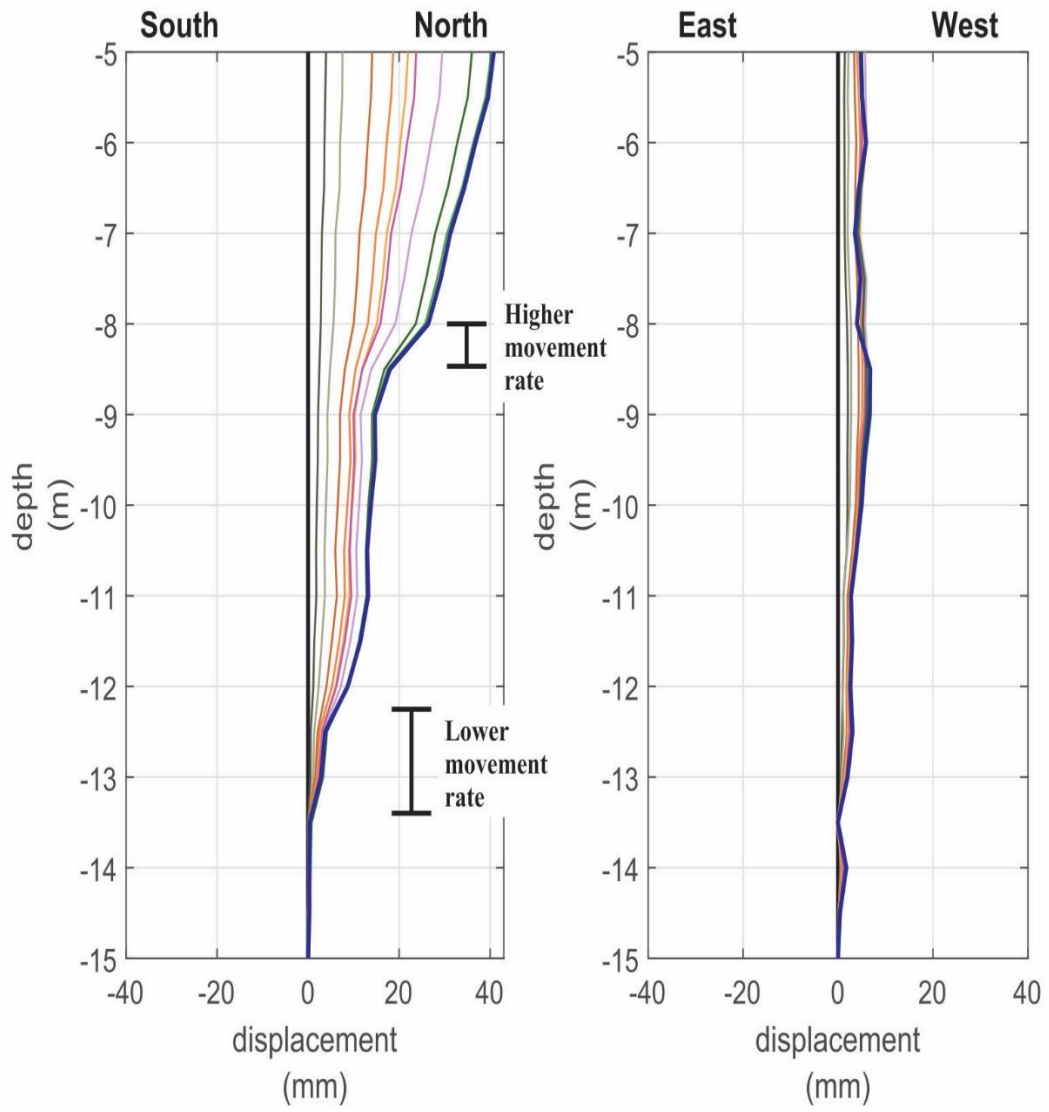
Figure 4.13 Incremental displacement graph of inclinometer data in DP-7 along with general classification of moving rate.

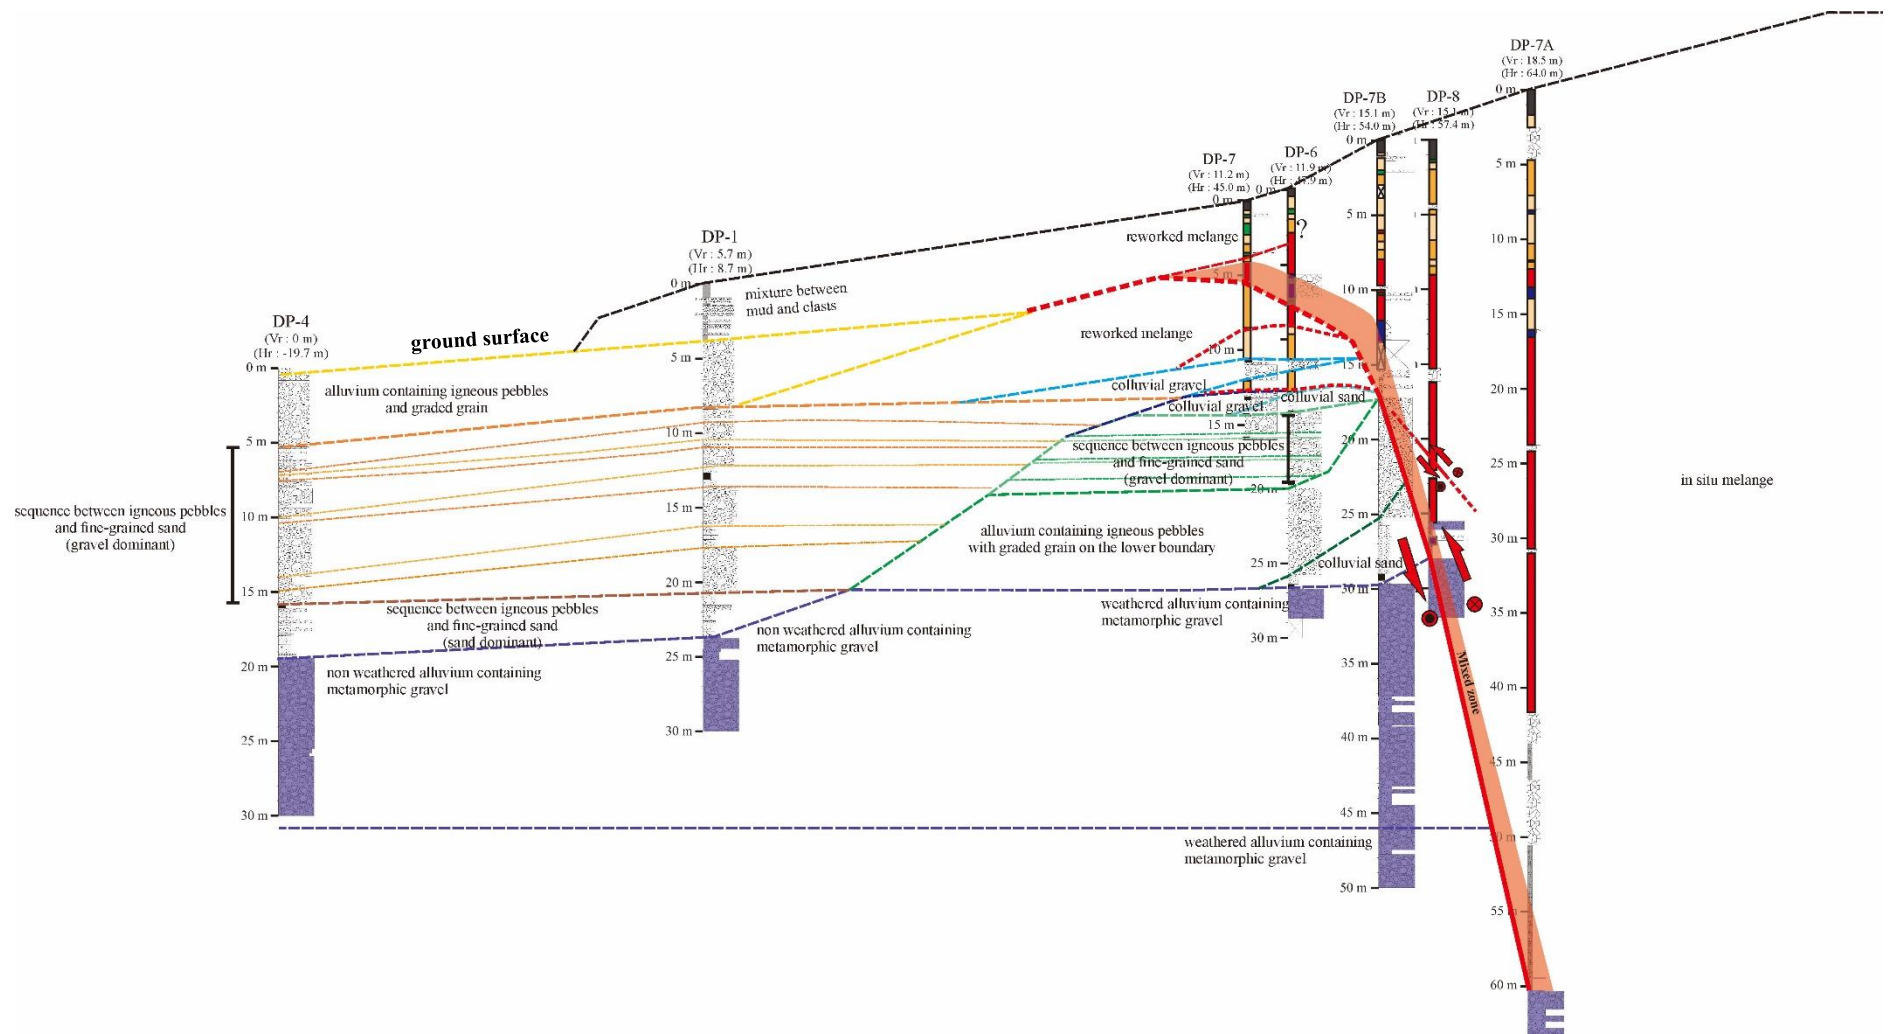
Figure 4.14 Core correlation. Bold-red-dashed line indicates the trace of the main Chihshang Fault. Thick-dashed colorful lines indicate correlation of the certain layer boundary among the boreholes.

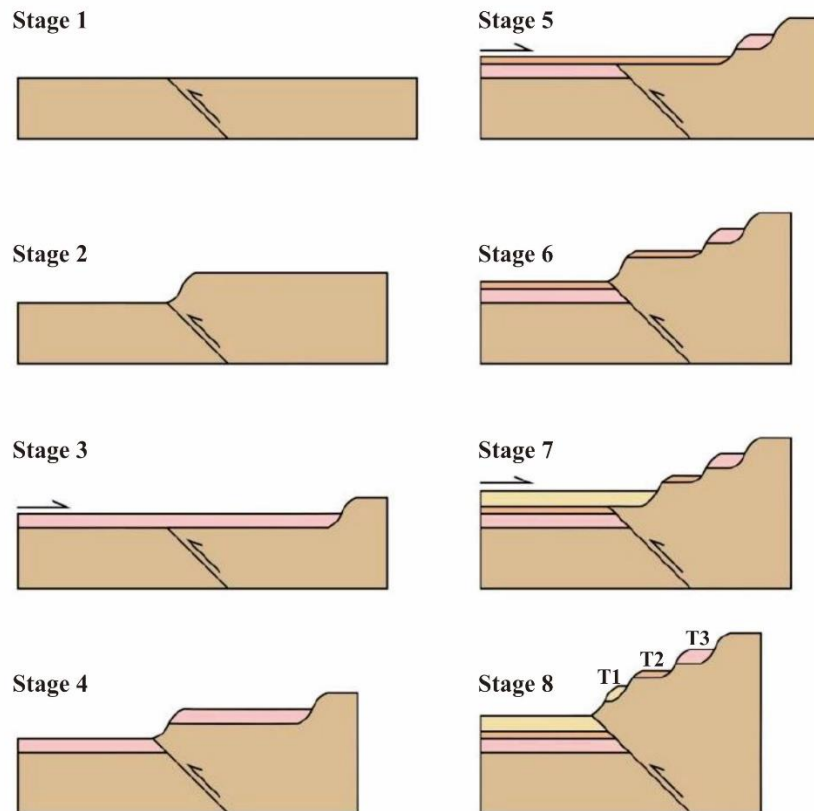
Figure 4.15 Map of terraces distribution along the Chihshang Fault with the schematic diagram of terrace formation mechanism (after Chang, Q., 2013).

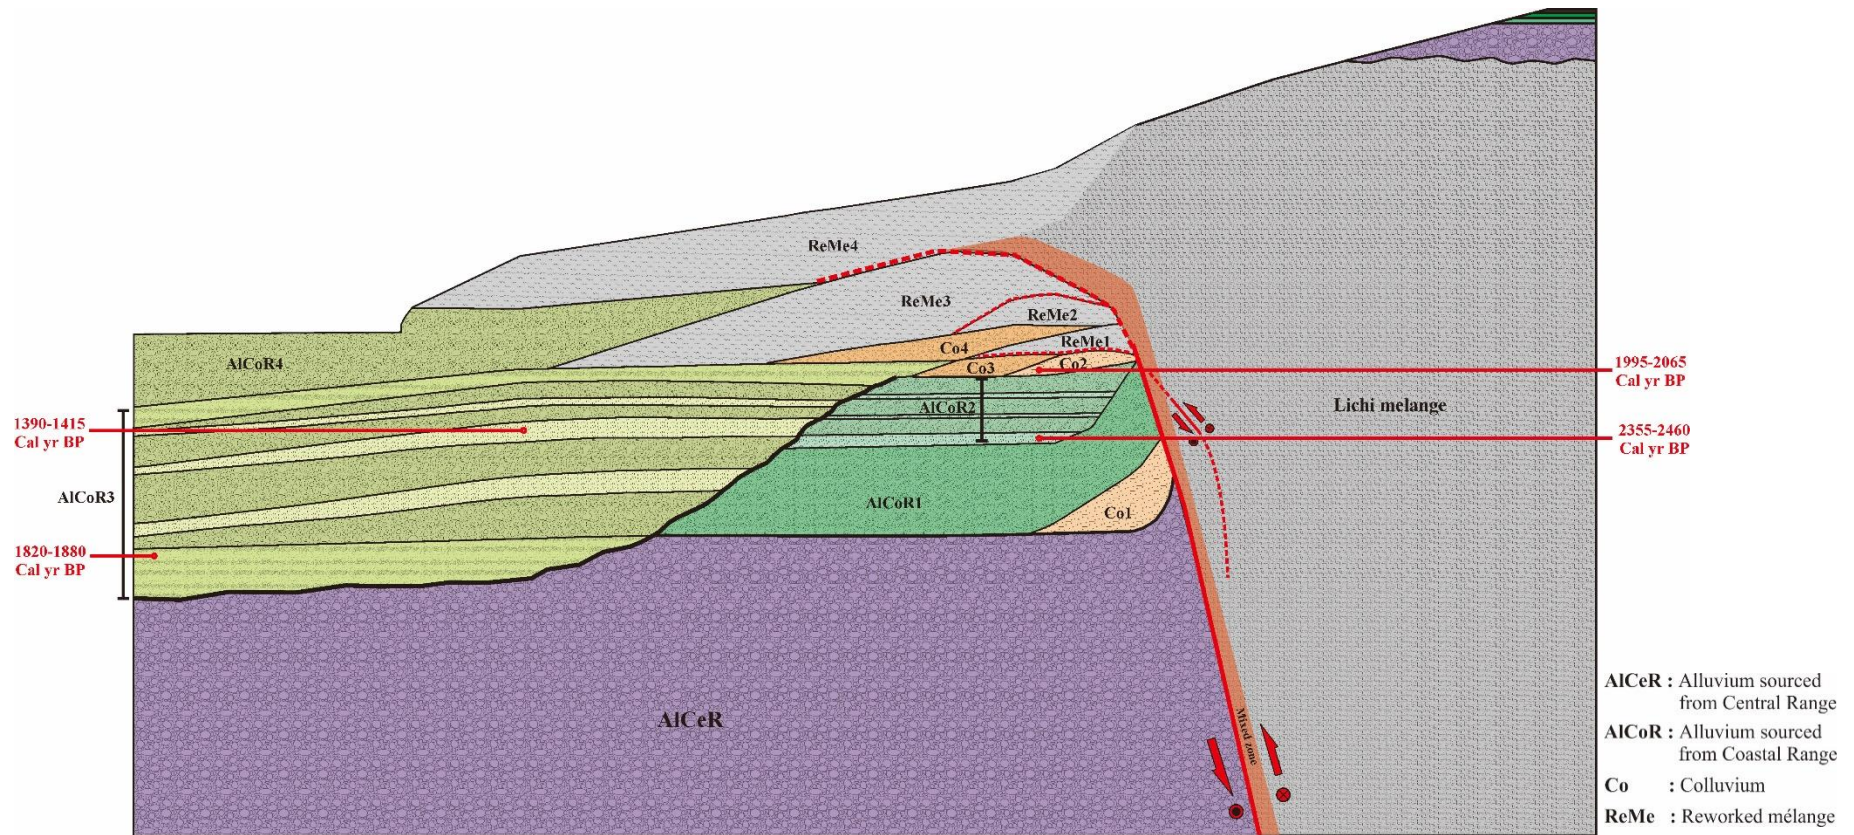
Figure 4.16 Diagrams of subsurface structure around the main Chihshang Fault with the core logs. The red line indicates the Chihshang Fault. The red arrows and the red circle with the symbol indicate the movement sense of the Chihshang Fault. The dot symbol in the red circle indicates the corresponding block relative to fault or sliding plane is moving outward the paper. The cross symbol in the red circle indicates the corresponding block relative to the fault or sliding plane is moving inward the paper. Red label indicates the dating data at the corresponding point.

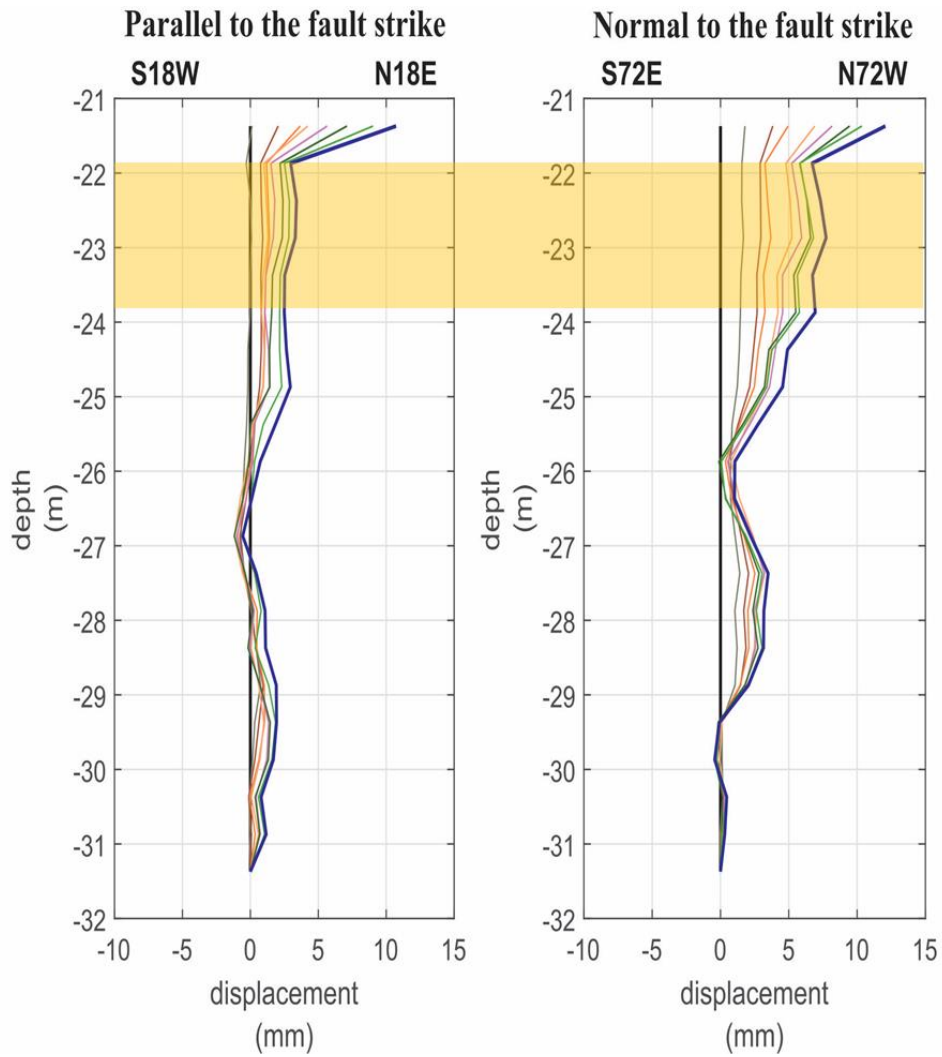
Horizontal movement vector of inclinometer in DP-8 at depth 21.87 m

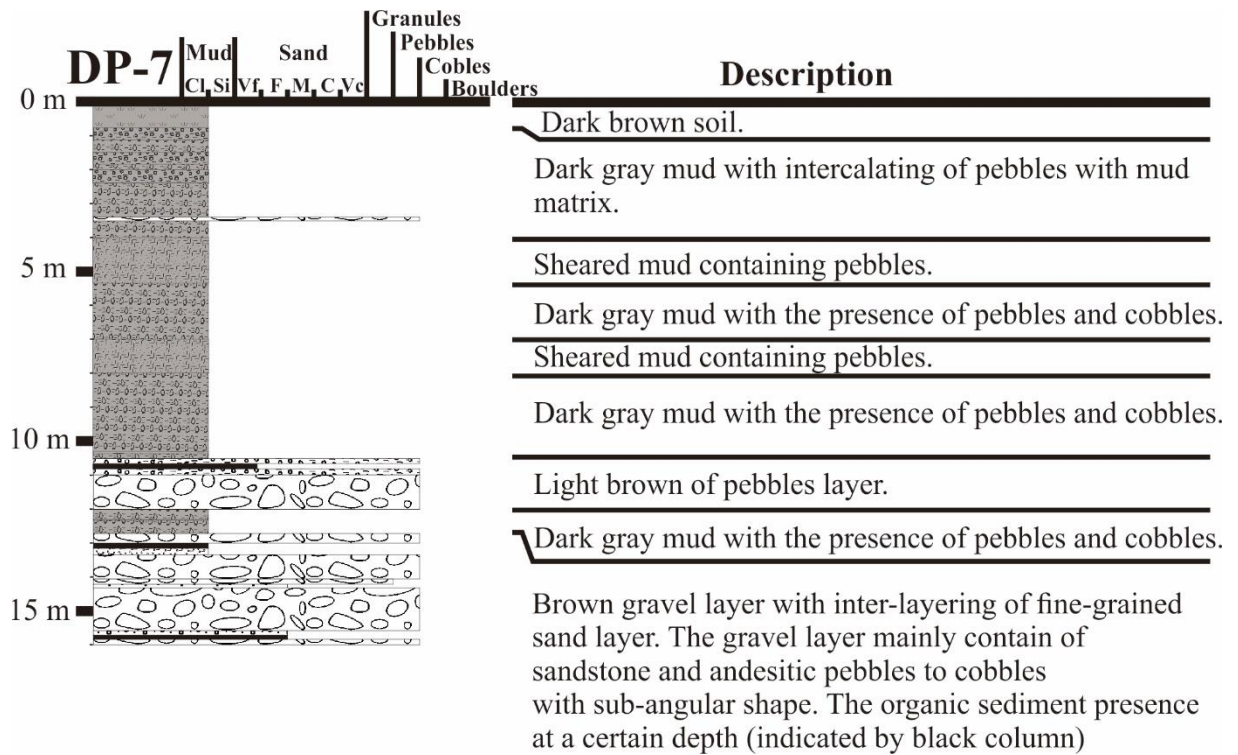
Figure A.4 Core logs of DP-7.

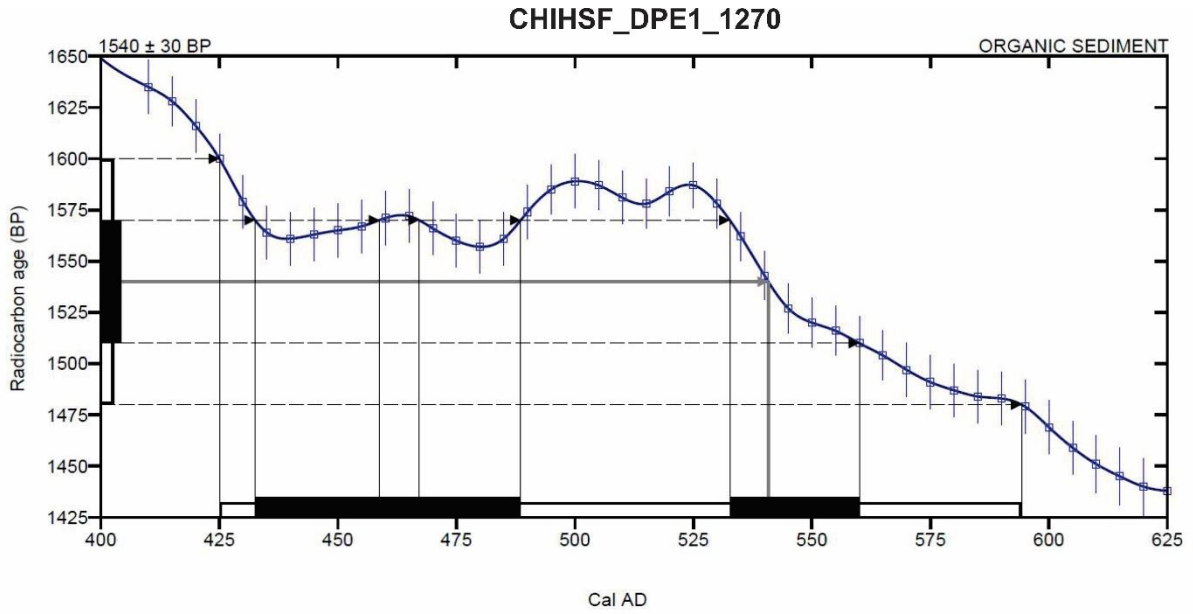
Figure A.21 Calibration of radiocarbon age of CHIHSF_DPE1_1270 based on INTCAL13 database.

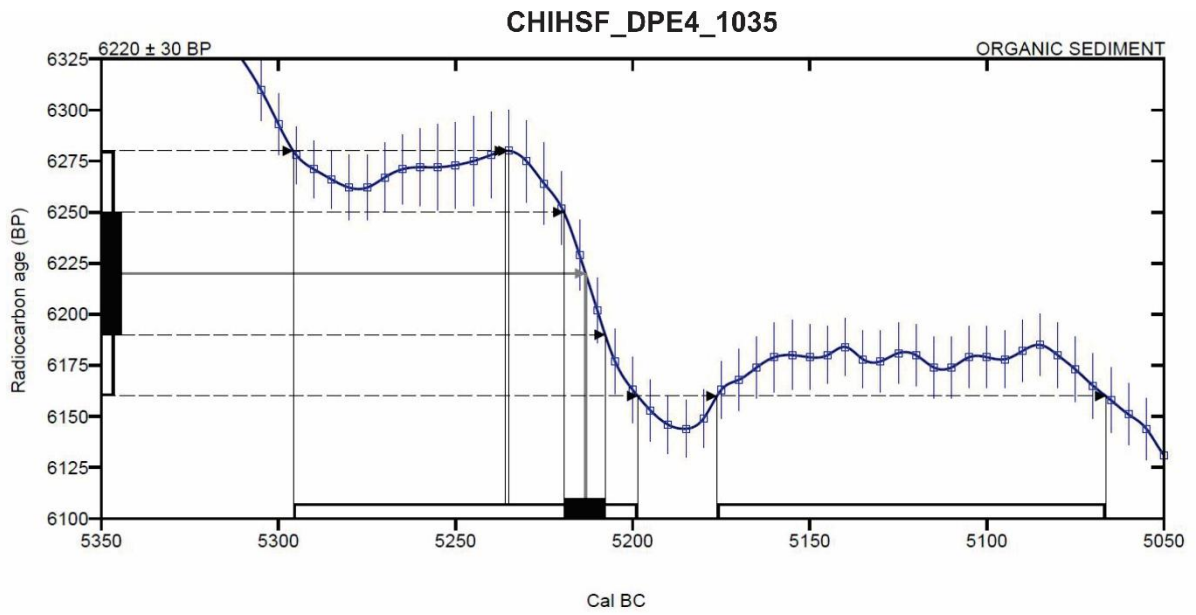
Figure A.22 Calibration of radiocarbon age of CHIHSF_DPE4_1035 based on INTCAL13 database.

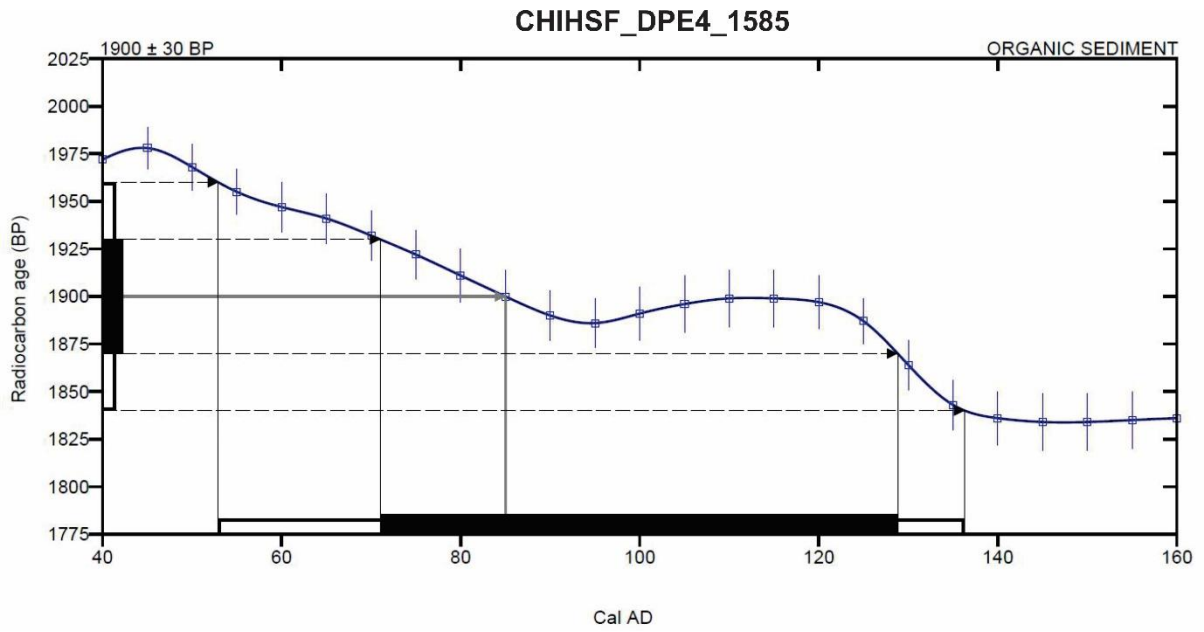
Figure A.23 Calibration of radiocarbon age of CHIHSF_DPE4_1585 based on INTCAL13 database.

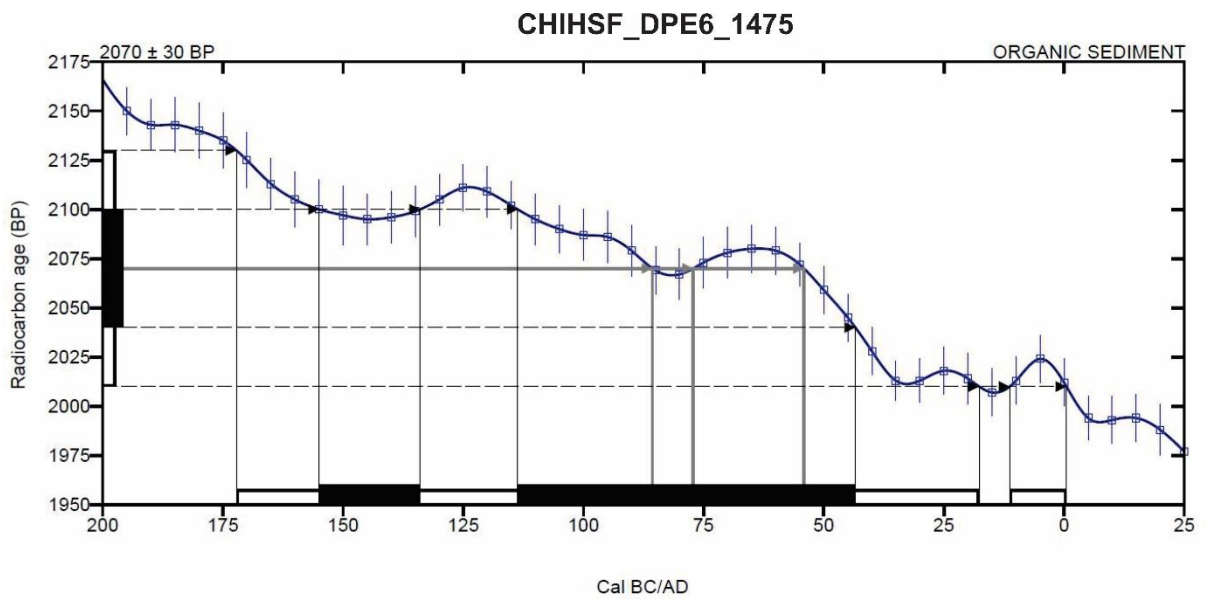
Figure A.24 Calibration of radiocarbon age of CHIHSF_DPE6_1475 based on INTCAL13 database.

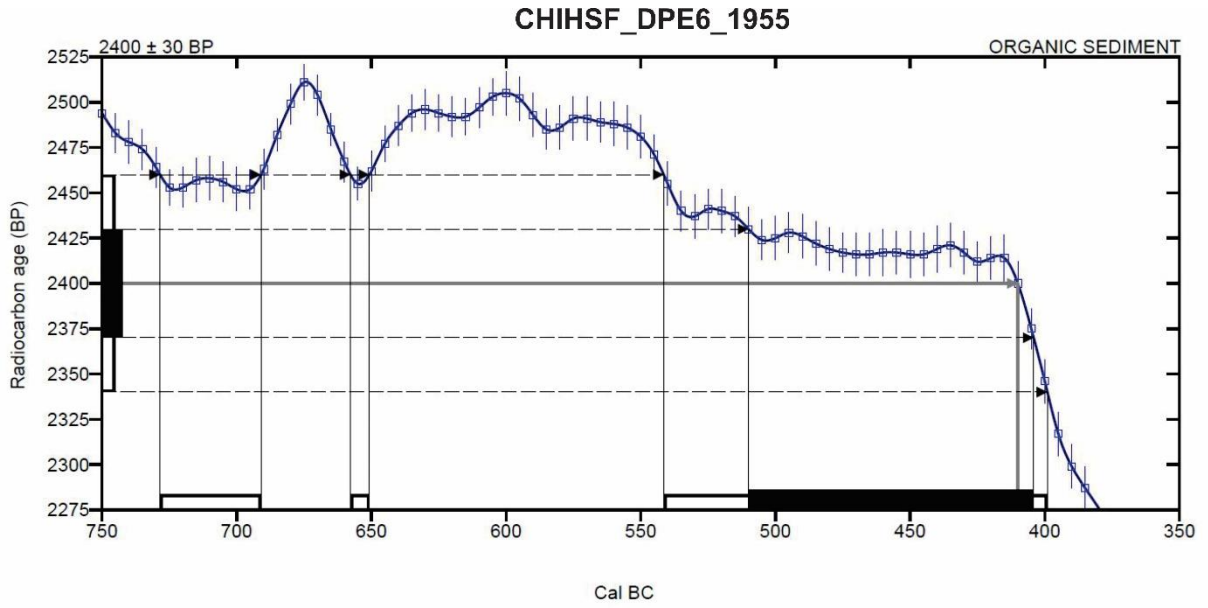
Figure A.25 Calibration of radiocarbon age of CHIHSF_DPE6_1955 based on INTCAL13 database.

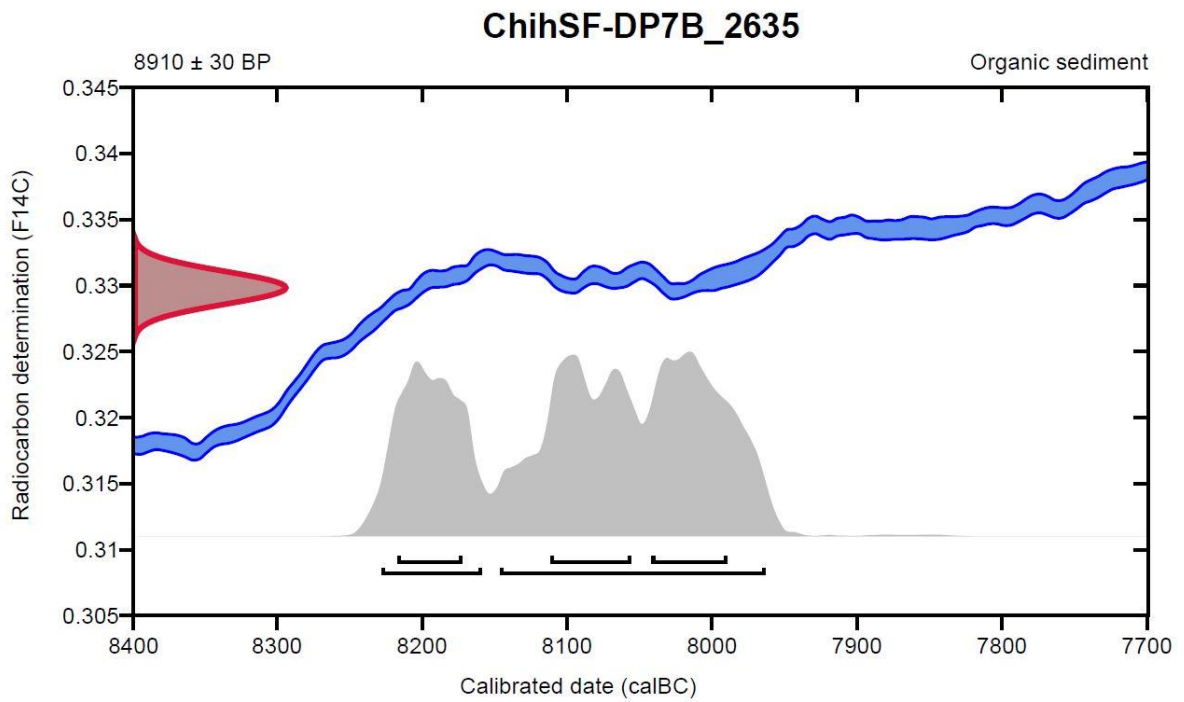
Figure A.26 Calibration of radiocarbon age of CHIHSF_DP7B_2635 based on INTCAL13 + NHZ2 database.

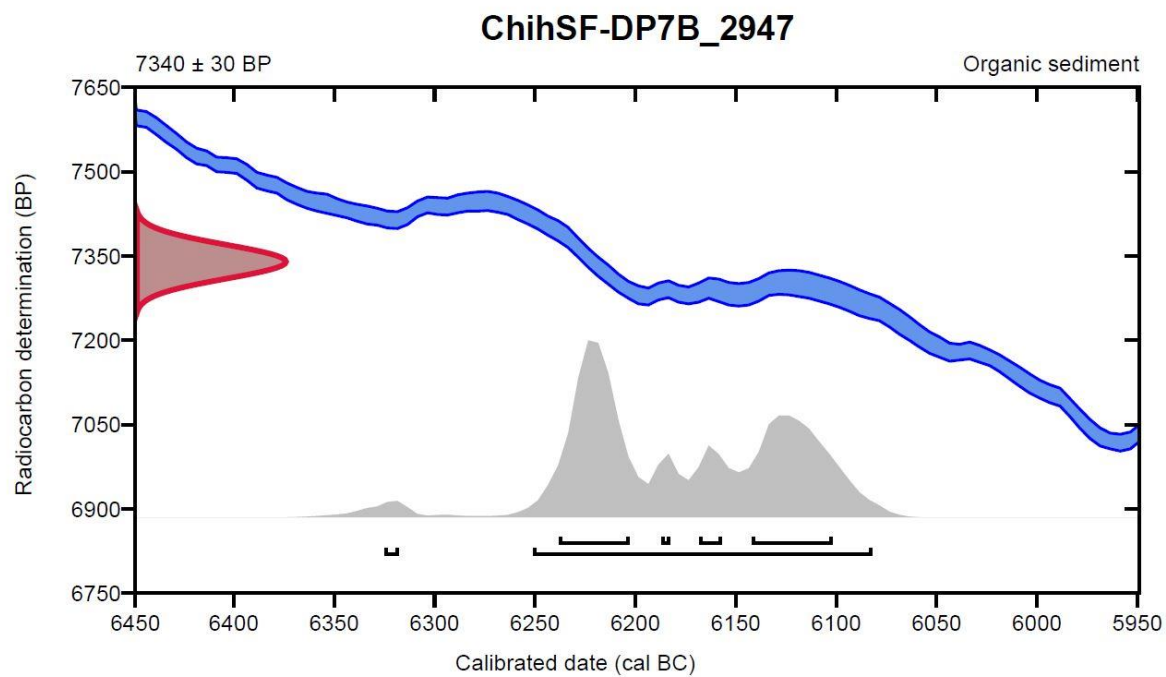
Figure A.27 Calibration of radiocarbon age of CHIHSF_DP7B_2947 based on INTCAL13 database.
