Survey Report: Dr16-8-11644; 2021/11/15

Benefits of Defining Geological Sensitive Zones in the Mitigation of Disasters Along Earthquake Fault Zones in Taiwan – The Case of Milun Fault

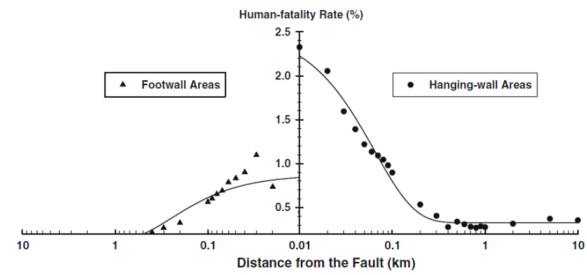
Fig. 3. Human-fatality rates versus distances from the surface trace for the hanging-wall and the footwall areas along the Chelungpu Fault (modified from Pai et al. [12]).

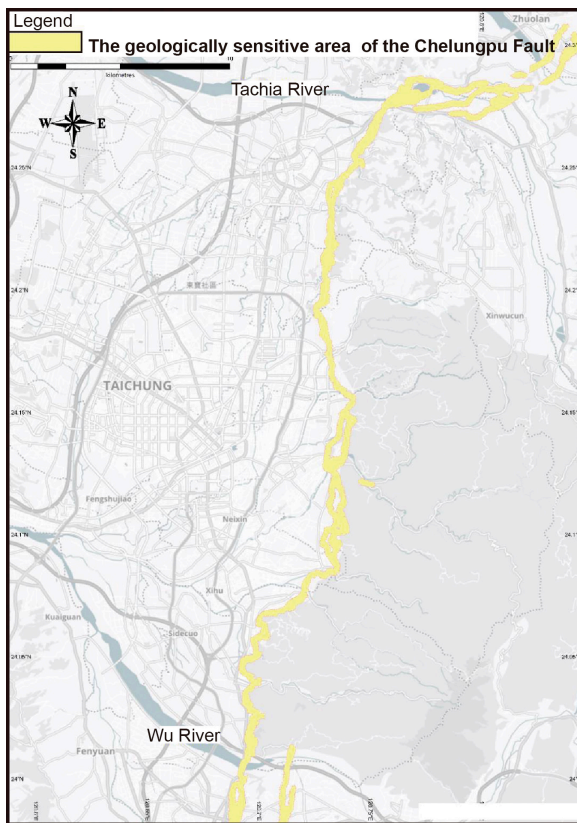
Fig. 5. GSA of the Chelungpu Fault north of the Wu River. The width of this area is approximately 300 m, including 100 m on the footwall and 200 m on the hanging wall.

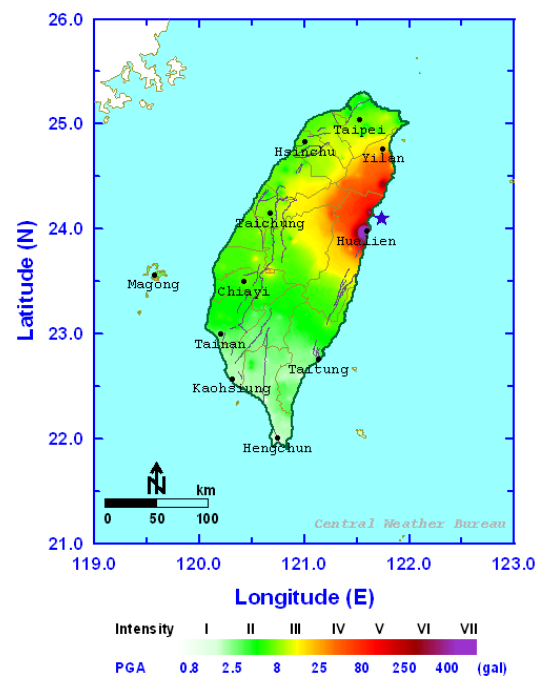
tivation of the Milun Fault produced surface ruptures on land extending from the coast in the north southeastward to downtown Hualien City (Figs. 4 and 6). This earthquake led to 17 deaths, nearly 300 injuries, and economic losses of more than 8 billion NT dollars [17].

Fig. 6. Earthquake intensity map of the February 6, 2018 M_w 6.4 event. Hualien is a regional hub and the largest city along Taiwan's east coast [16]. The black lines on land denote active faults.

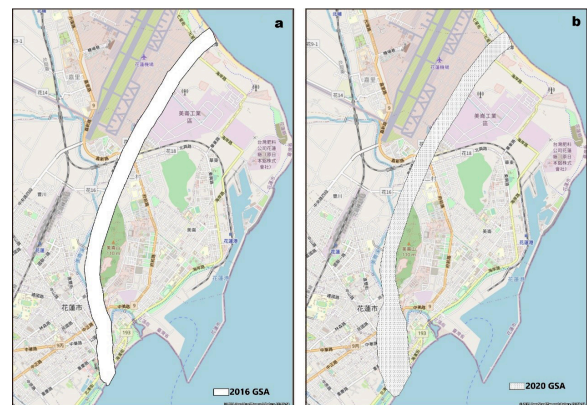
Fig. 7. Milun Fault GSA. CGS released the first version of the Milun Fault GSA in 2016 (a) and the revised version in 2020 (b). There is a 0.5 km² area of increase in the revised version, mainly in the southern section.

There were traceable surface ruptures along the Milun Fault from the 1951 Hualien Earthquake. The first public announcement of the Milun Fault GSA (Fig. 7a) was made on December 21, 2016, by the CGS. The 2018 Hualien Earthquake provided new evidence of the sur-

face ruptures of the Milun Fault. A revised version of the Milun Fault GSA was announced on April 28, 2020 (Fig. 7b).
