Complexity of near-surface deformation and subsurface structure of the Chihshang creeping fault-line scarp, eastern Taiwan: insights from integration of geological and geophysical data

Abstract

Highlights

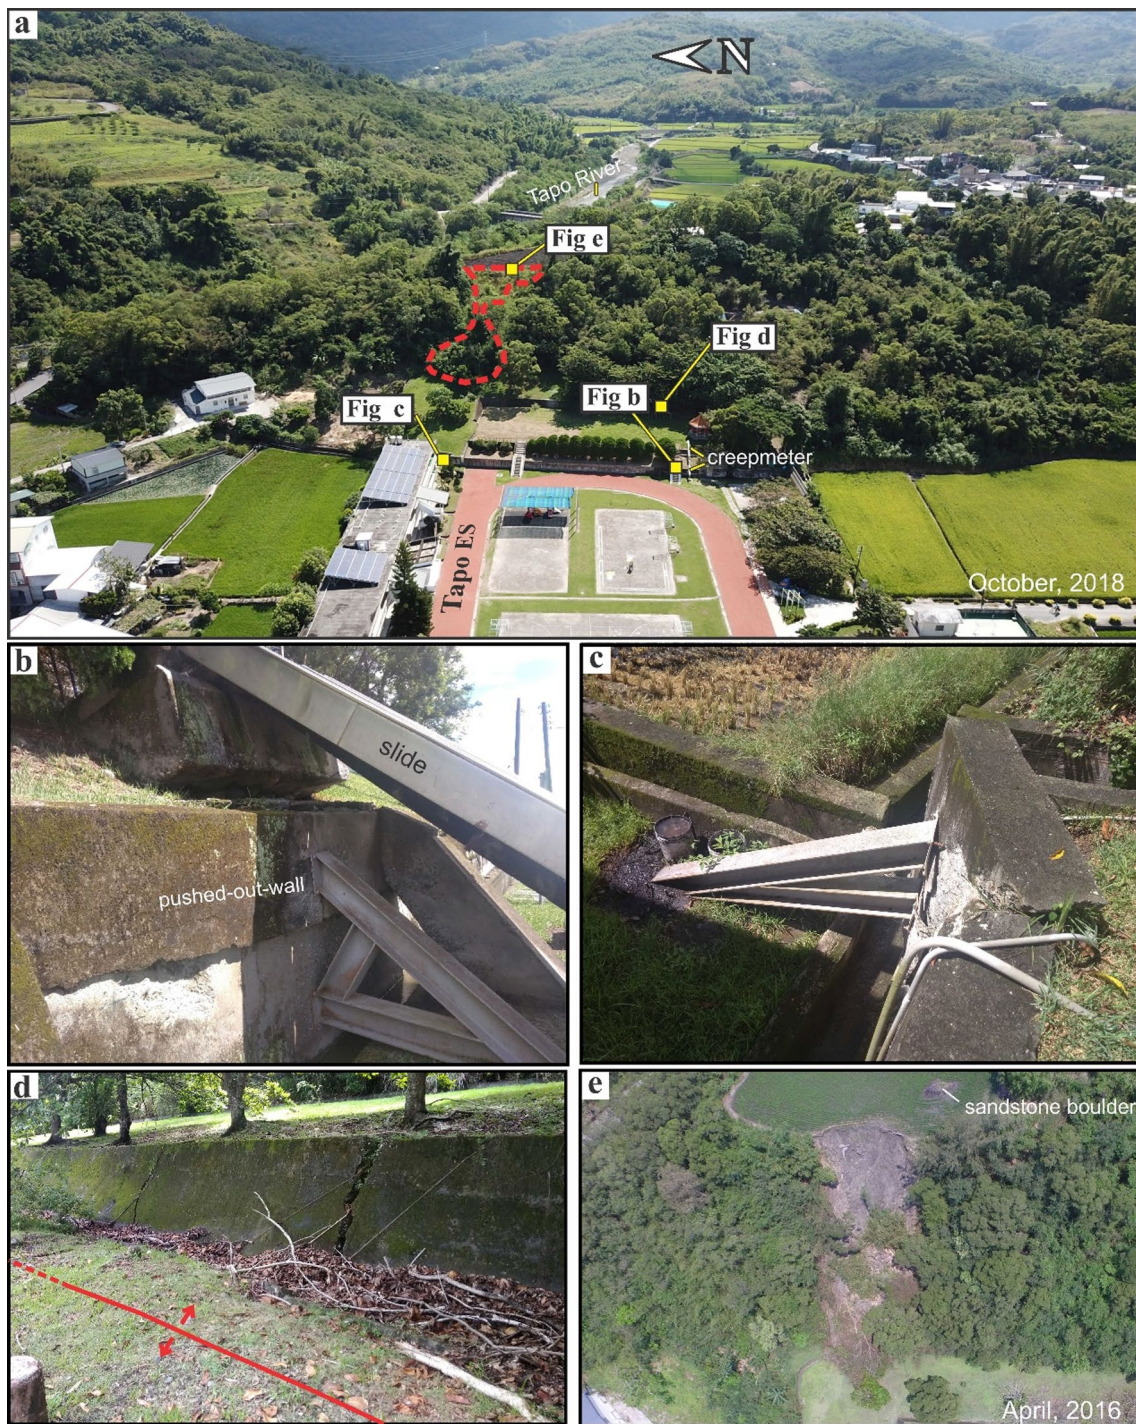
Fig. 3 Surface deformation features on the ChF-line scarp in Tapo ES area. **a** Oblique view of the Tapo ES area. Taken on 5 October 2018 by a camera drone. The red dashed line outlines the remains of the landslide in 2016 (see Figure e). **b** Tilted platform of the slide and bulging wall. **c** Torn apart concrete wall. **d** Cracked concrete wall and bulging ground. **e** A landslide incidence. Drone photo taken on 16 April 2016

the bottom suffered some damage in the form of vertical open cracks (Fig. 3d) and the ground in front of it bulged. These phenomena implied that downward ground movement had also occurred on the slope of the hill.

A decimeter-sized debris flow occurred on the slope after heavy rains in April 2016, resulting in a cirque at the edge of the hilltop and a mound of earth along with toppling trees on the stages (Fig. 3e). The mound consisted of mainly aqueous mud across an area of

approximately 30 × 20 × 1 m on 16 April, 2016. The cirque exposed a fresh outcrop composed of dominant mud and sparse fragments of sandstone. In addition, there was a sandstone boulder (approximately 1.5 m × 1 m × at least 0.5 m) 10 m east of the cirque in the middle of a paddy field (Fig. 3e), most likely an exotic rock embedded in Lichi mélangé before the exhumation to the surface. In late 2018, the remains of the slope failure were wiped away and covered by vegetation (Fig. 3a).

The hill abutting the Tapo ES is densely covered by vegetation except for the recreation area (Figure 3a). The hillslope south of the recreation area has a moderately steep angle ranging between 10° and 30° and increasing uphill. Under such conditions, an excavation to create an access road was necessary so that a drilling machine could be transported to certain positions on the slope. This excavation created not only an access to the drilling sites, but also new exposure and an access to outcrops hidden in the hill. The new exposure consisted of mélange-related material containing mainly mud with fragments of sandstone (Figure 9a). An outcrop of sedimentary deposit (Figure 9b) was found on the slope close to the hilltop. The upper deposit was thickly bedded alluvial layers sourced from the Coastal Range; one

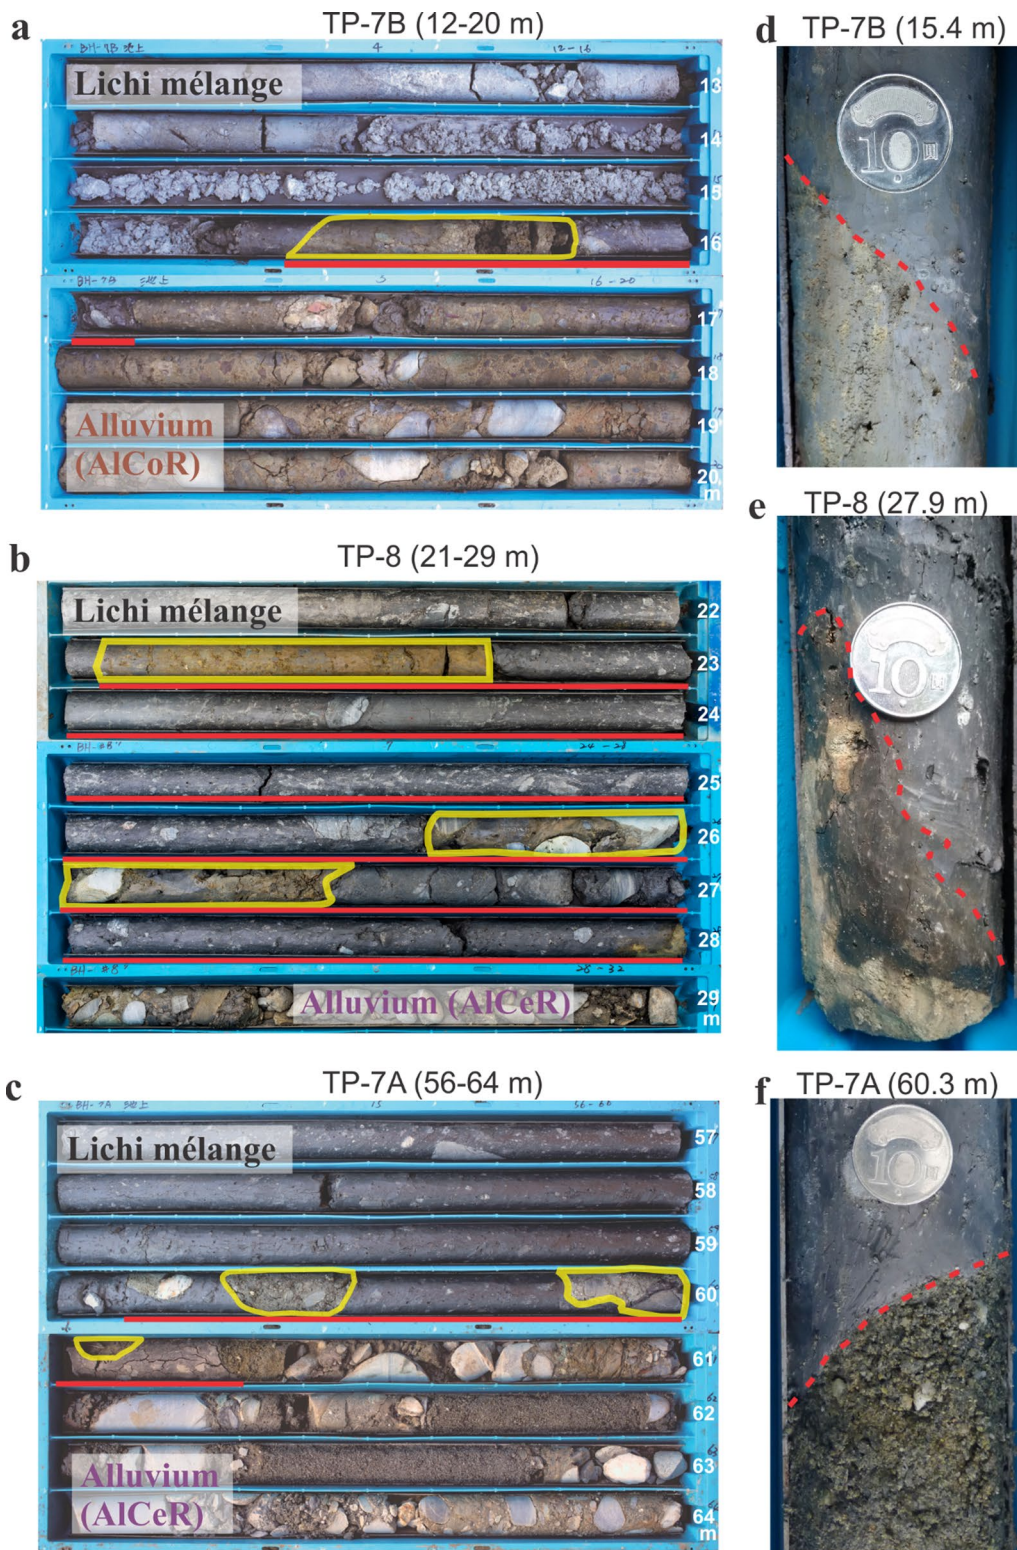
Fig. 7 Fault contacts/fault zones in the rock cores. Red lines highlight the mixed zone/fault zone between Lichi Mélange and alluvium deposit. Yellow polygons denote deformed alluvium deposits in the Lichi Mélange. **a** Rock core of TP-7B at depths of 12 to 20 m. **b** Rock core of TP-8 at depths of 21 to 29 m. **c** Rock core of TP-7A at depths of 56 to 64 m. **d** Fault contact between mud of Lichi Mélange (at right) and fine-grained sand of alluvium (at left) in TP-7B at depth of 15.4 m. **e** Fault contact between mud of Lichi Mélange (at right) and fine-grained sand of alluvium (at left) in TP-8 at depth of 27.9 m. **f** Fault contact between mud of Lichi Mélange (at left) and very coarse-grained sand of alluvium (at right) in TP-7A at depth of 60.3 m

The inclinometer was utilized at depths of 21.3 to 31.3 m of TP-8 to confirm whether the main fault was actively moving. Distinct displacement gradients were observed at depths of 25.8 to 22.3 m for the North–South component and at depths of 27.3 to 23.3 m for the West–East component. Roughly, the depth range corresponded to the main fault-affected zone at depths of 28.0–22.1 m (Fig. 7). Such small amplitudes of horizontal deformation and changing displacement gradients may have resulted from the highly steep fault with a dip of greater than 75° (Fig. 8) and the complexity of its affected zone (Fig. 13d), which was two sections of alluvial materials from the footwall embedded in the sheared mélange within the zone (Fig. 7b) and two high-angle faults side by side at depths of 22.2 to 22.5 m (Fig. 13d) in the upper section.

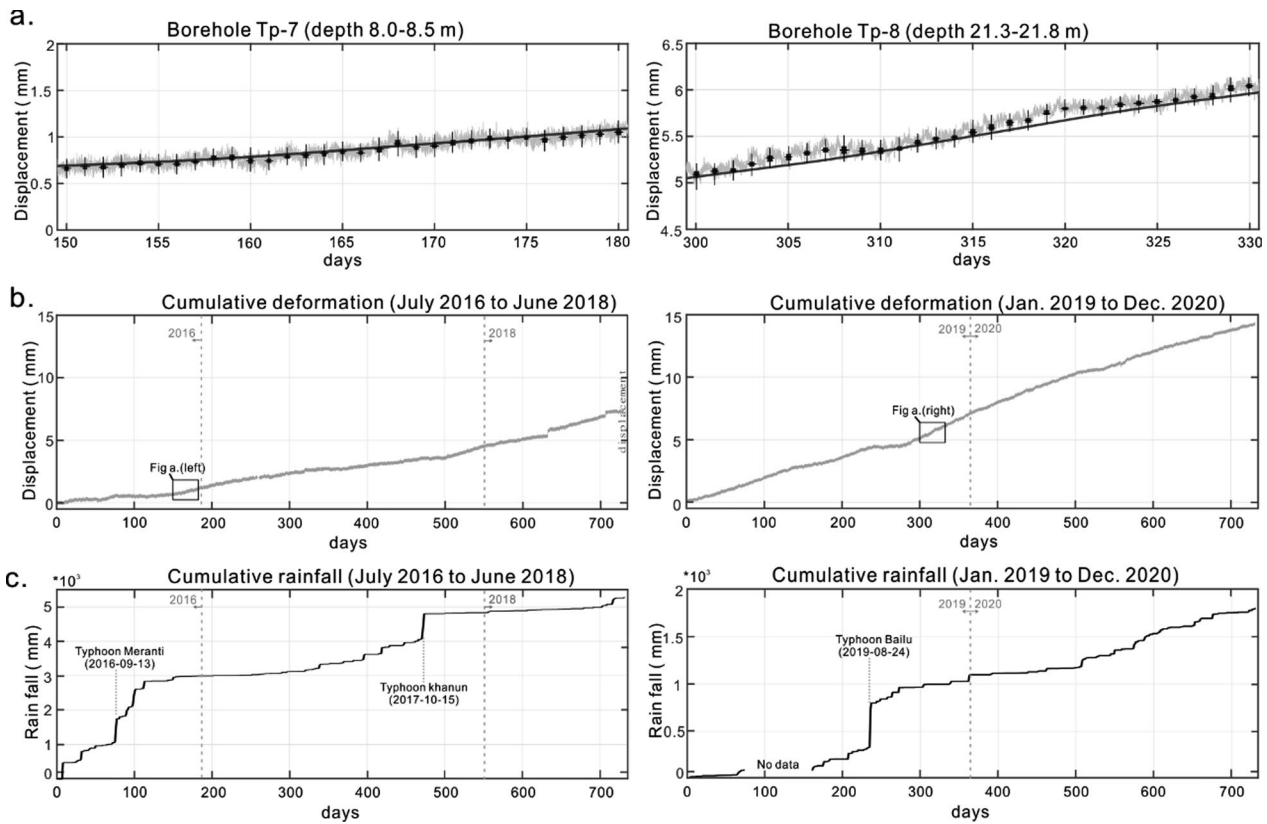
Fig. 11 Subsurface deformation and rainfall in Tapo. **a** Oscillation and trend of the data from two individual inclinometer sensors. **b** Two-year cumulative deformation for the same two individual segments derived from inclinometer monitoring. **c** Two-year cumulative rainfall. Data source was the Chihshang rainfall station of Taiwan Central Weather Bureau, the location of which is shown in Fig. 1b

Considering the abundance of data, we derived mean values from daily data for all individual segments. Then, we smoothed the daily means to eliminate any outliers and find a regression curve to fit them, shown

as black curves in Fig. 11a. Based on the derived regression curves, we attained the relative displacement of a specified segment over a specified time period in reference to the base point of the inclinometer (Fig. 10c).

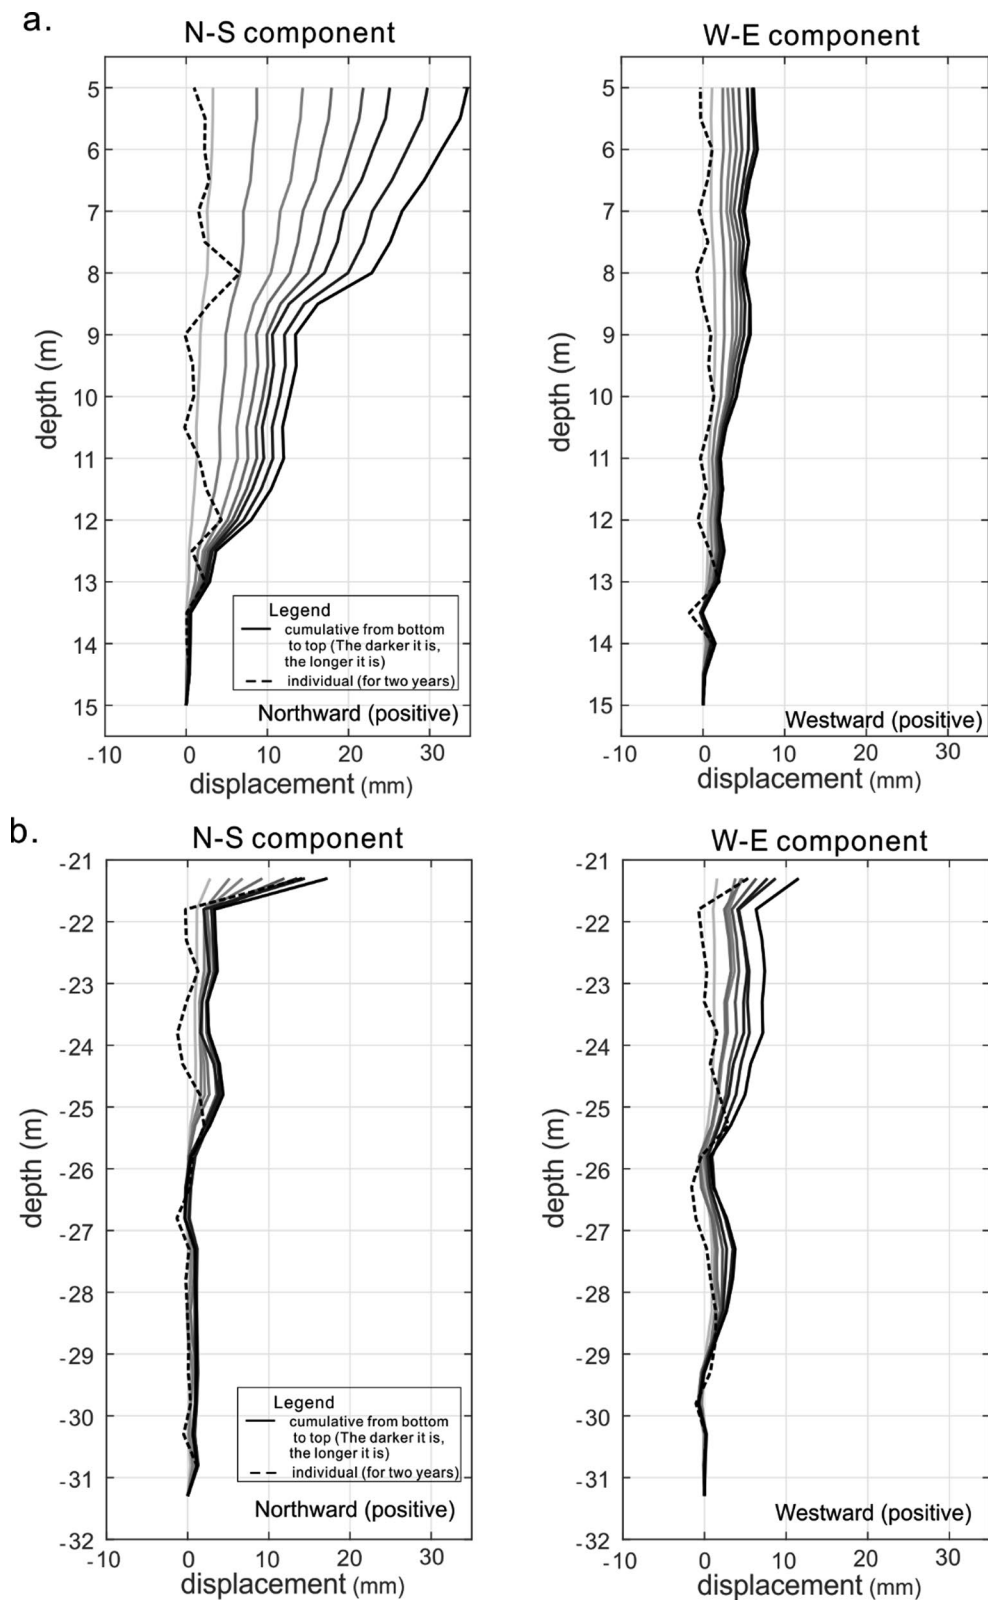
Fig. 12 Subsurface deformation recorded via inclinometer. Cumulative displacements with depth are shown with intervals of 3 months over the 2 years in addition to cumulative displacement of individual segments over 2 years. Individual segments were all 0.5 m long. **a** Relative displacement at depths of 5 to 15 m in TP-7 from 1 July 2016 to 30 June 2018. **b** Relative displacement at depths of 21.3 to 31.3 m in TP-8 from 1 January 2019 to 31 December 2020

Figure 12 shows the plots of cumulative displacement with depth for all segments of the inclinometer installed in TP-7 and TP-8. Displacement increments are shown with intervals of 3 months over the 2 years. The inclinometer was set to depths of 5 to 15 m of TP-7 to confirm whether the contacts of the Lichi Mélange-related material and AlCoR (Fig. 8a) were actively moving. The cumulative horizontal deformation at depths of 5 to 15 m of TP-7 was 34.7 mm towards the north and 6.2 mm towards the west over the two years (Fig. 12a). The relatively intense northward movement occurred at depths of 13.5–13.0, 12.5–12.0, and 9.0–8.0 m and stable northward movement occurred at depths of 7.5 to 5.5 m. Interestingly, the bottommost contact of the two lithologic groups was located at a depth of 12.7 m within the segment in between the two active segments. The rock core at depths of 13.5–13.0 m was composed of sandy gravel
